Minnesota Home Inspectors

Inspection Report

Property Address:

Any Street

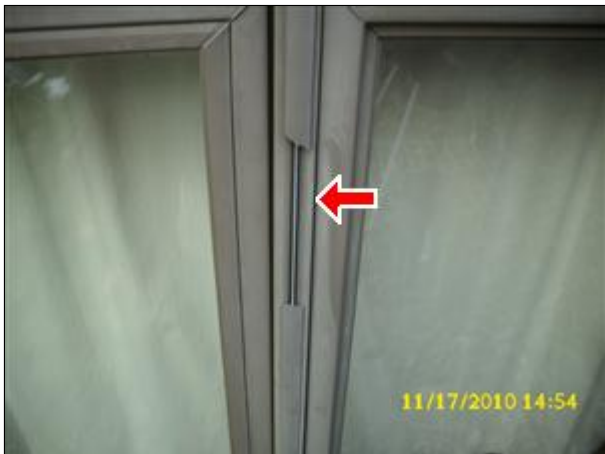
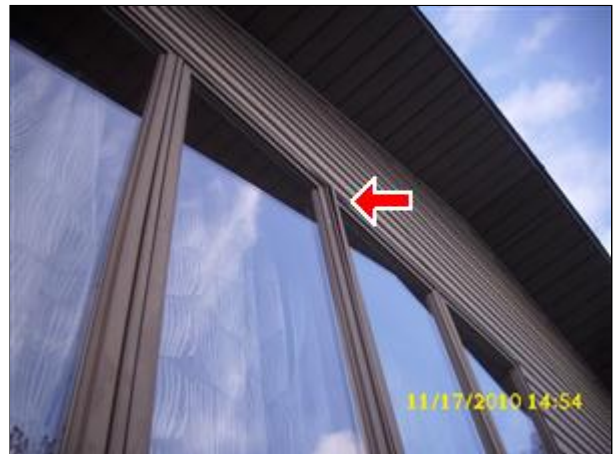
- (2) Missing / damaged window mull covers observed on the exterior. Repairs are necessary to prevent water intrusion.

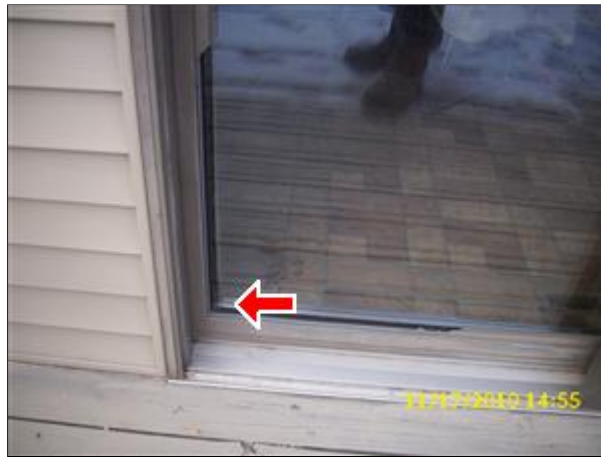
- (3) Missing glass stops observed on the patio door. Replacement is necessary to prevent water intrusion and to prevent the glass from falling out.

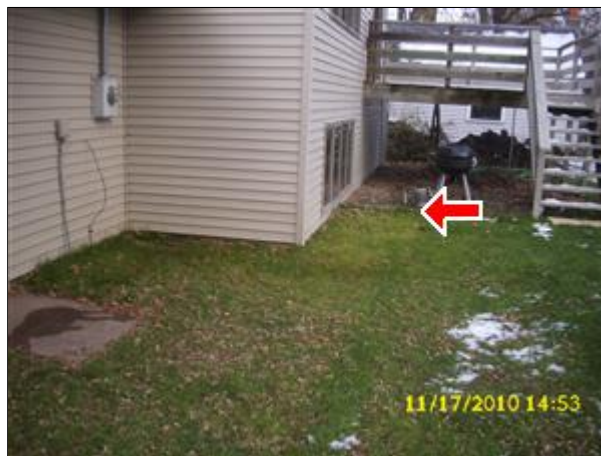
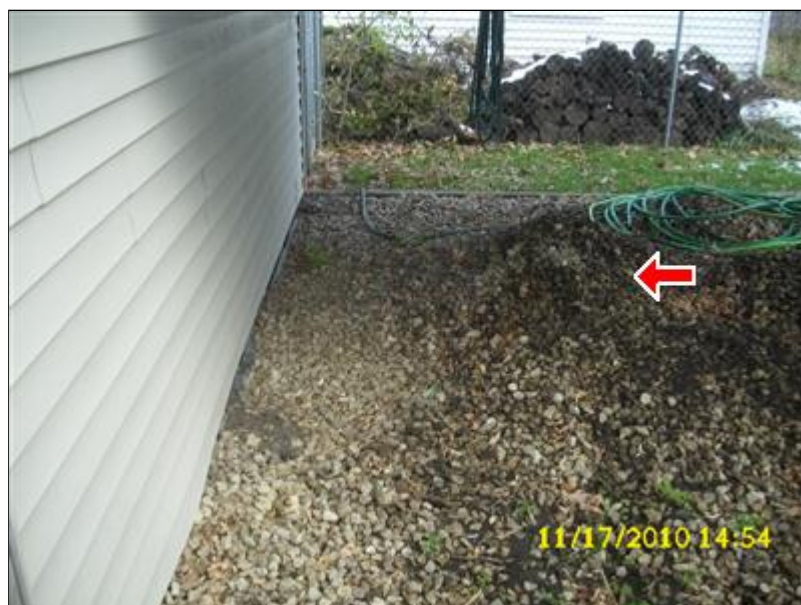
- ☒ The ground around the building slopes directly towards the building. This will result in water pooling next to the foundation leading to other problems. A slope of at least one inch drop per foot away from the building for at least the first six feet is advised.

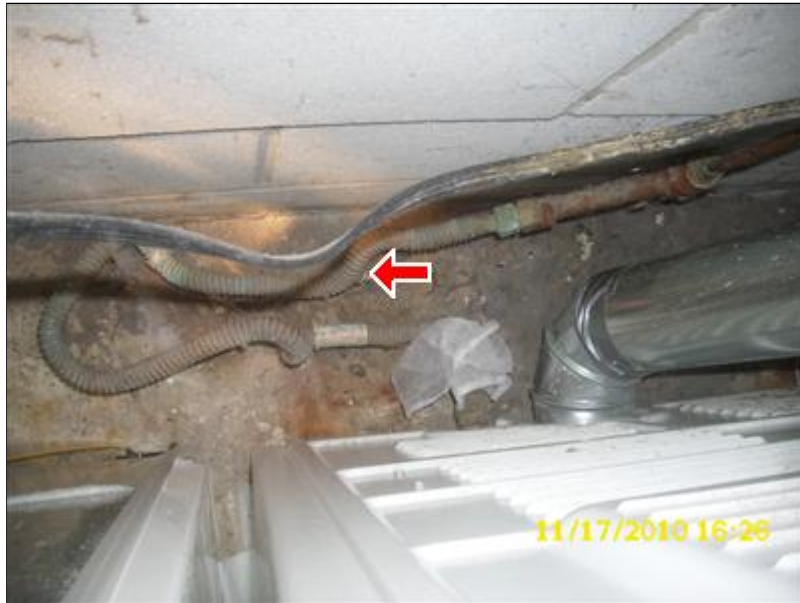
- The flexible gas lines used at the dryer connection are no longer approved by the American Gas Association. Due to concerns with pin hole leaks in the connectors replacement with approved connectors is recommended.

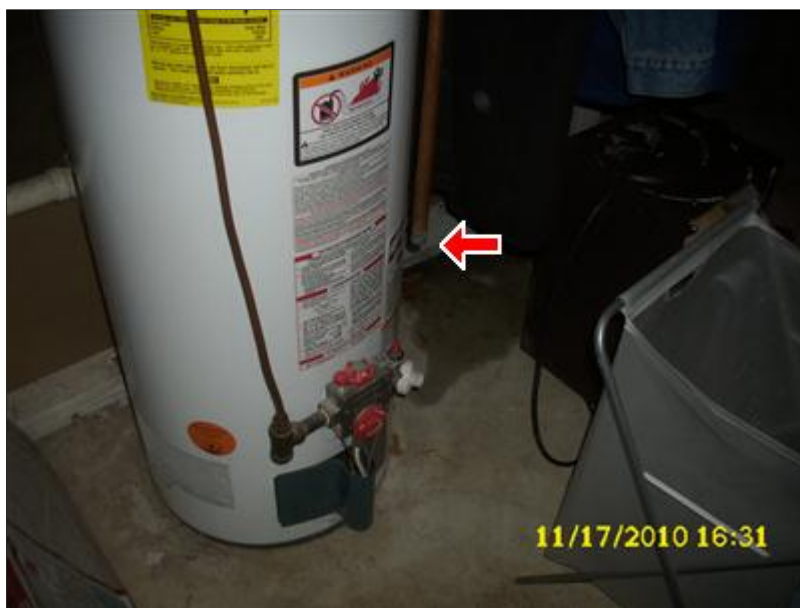
- The extension for the pressure relief valve is improper. This is an important safety device that will direct any water released from the pressure relief valve to a safe area. This extension should be no less than three-quarters of an inch inside diameter, terminate within six inches of the floor, self draining, and not be threaded on the end.

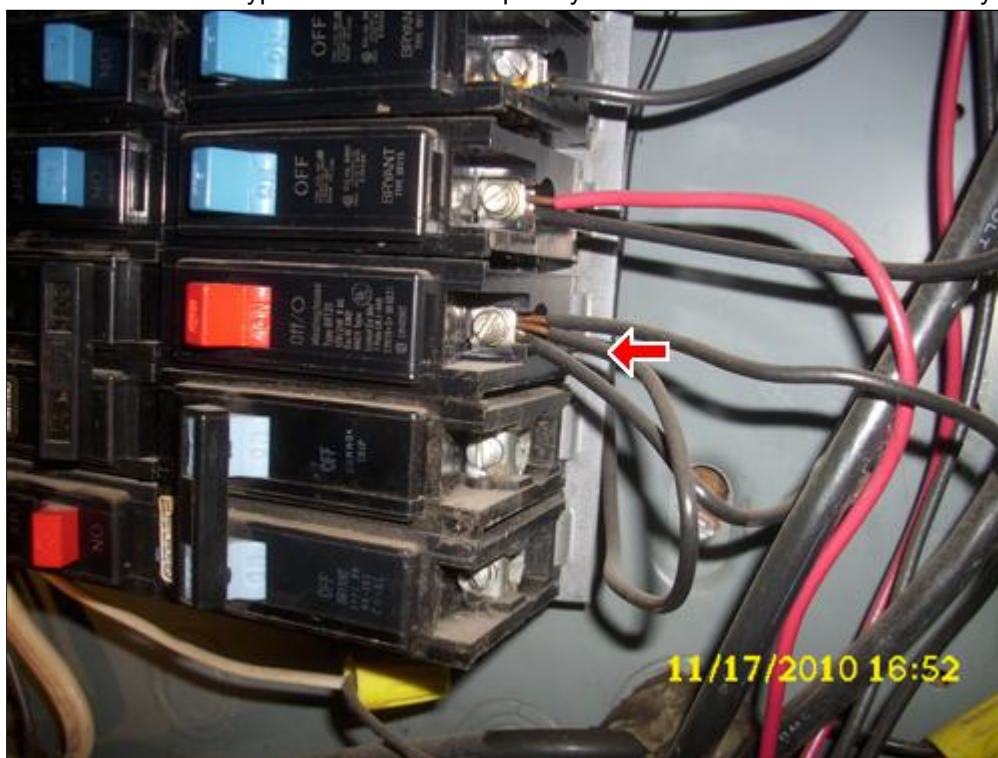
- ☒ (2) More than one wire is observed at individual electrical disconnects. Manufacturer requirements dictate that only one wire is to be connected to this type of disconnect. Repair by a licensed electrician is necessary.

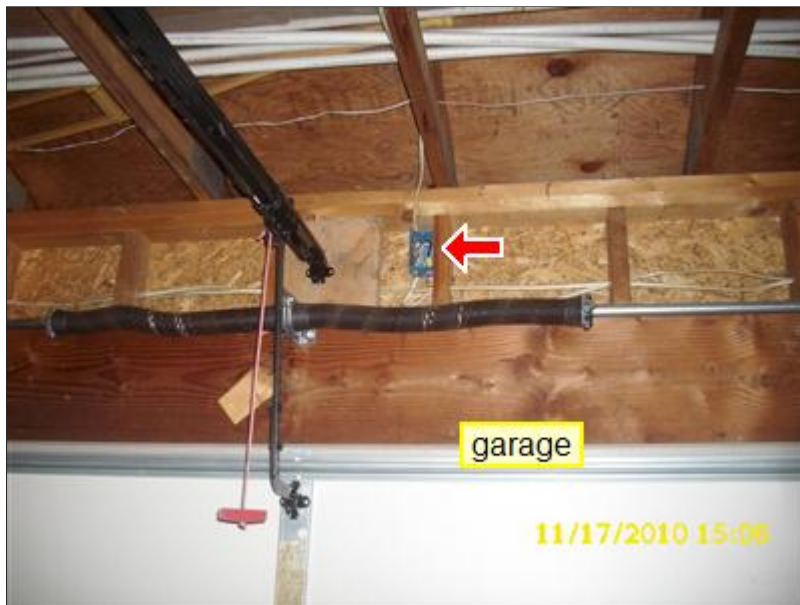
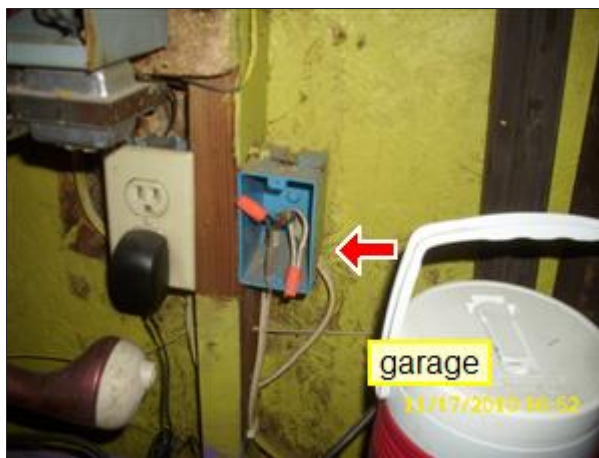
- ☒ (2) Open electrical junction boxes observed. All junction boxes should be sealed with an approved cover for safety.

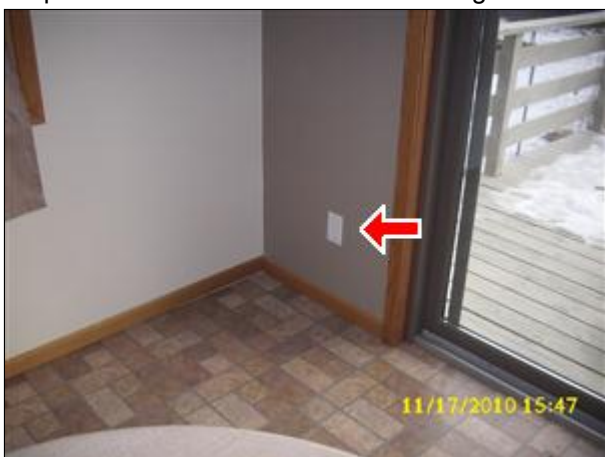
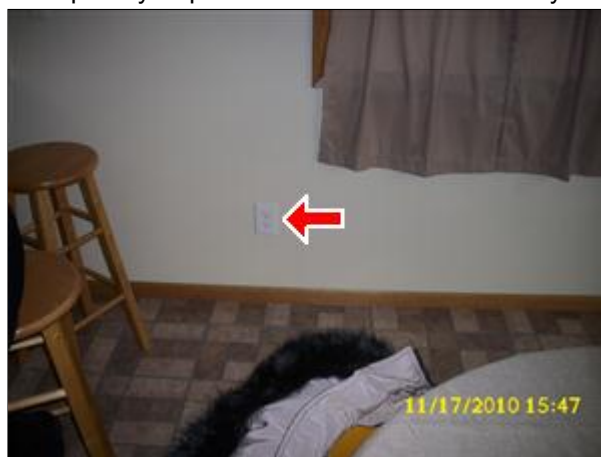
❌ (3) Inoperable outlets observed in the dining room. Review and repair by a qualified electrician is necessary.

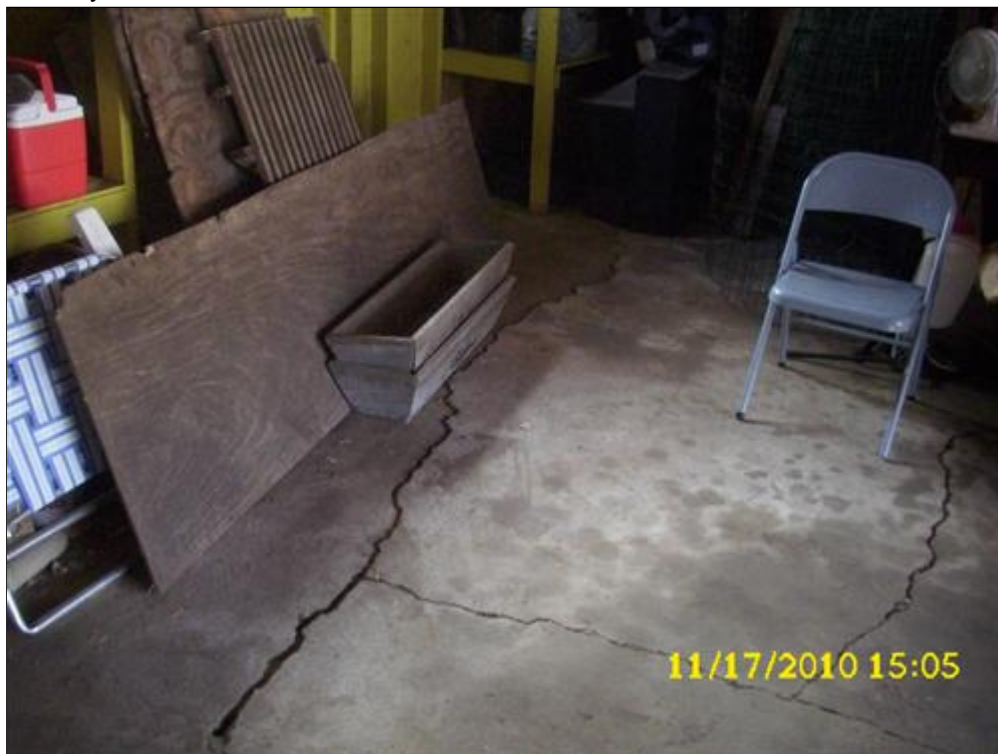
- ⊗ Heaving of the garage floor observed. This usually indicates problems in the sub-surface area below the slab. Although primarily cosmetic, this can be an indication of structural problems and further review by a qualified contractor is necessary.

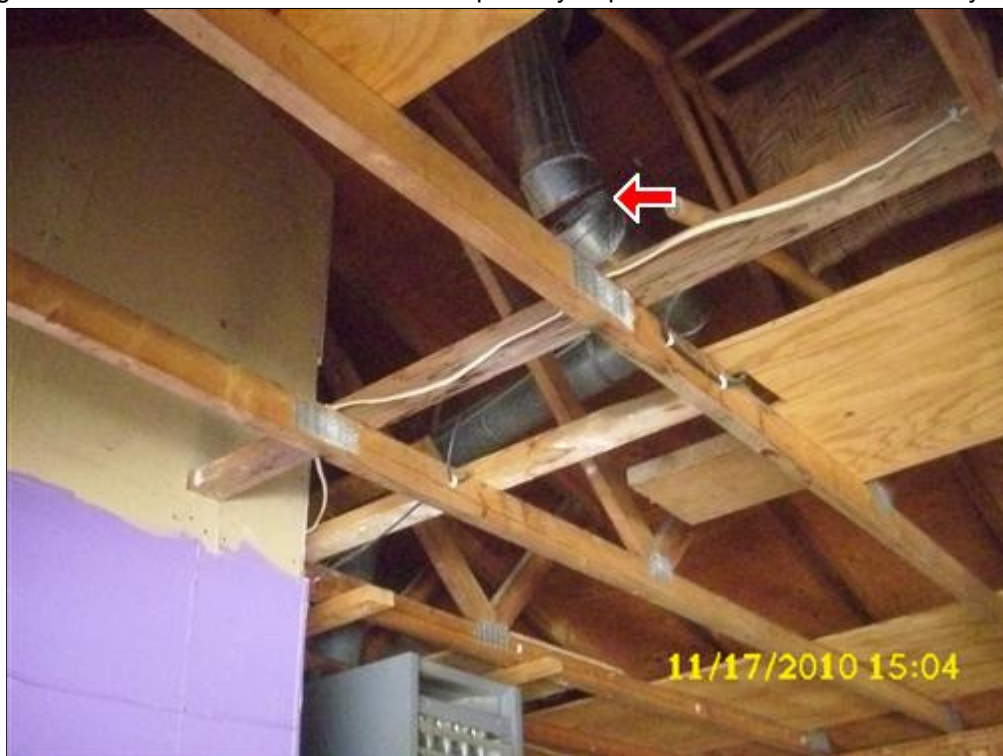
- ☒ (1) The garage heater is improperly installed. Disconnected vent pipe, the vent is too near combustibles, and the electrical wiring is a cut extension cord. Review and repairs by a qualified technician is necessary.

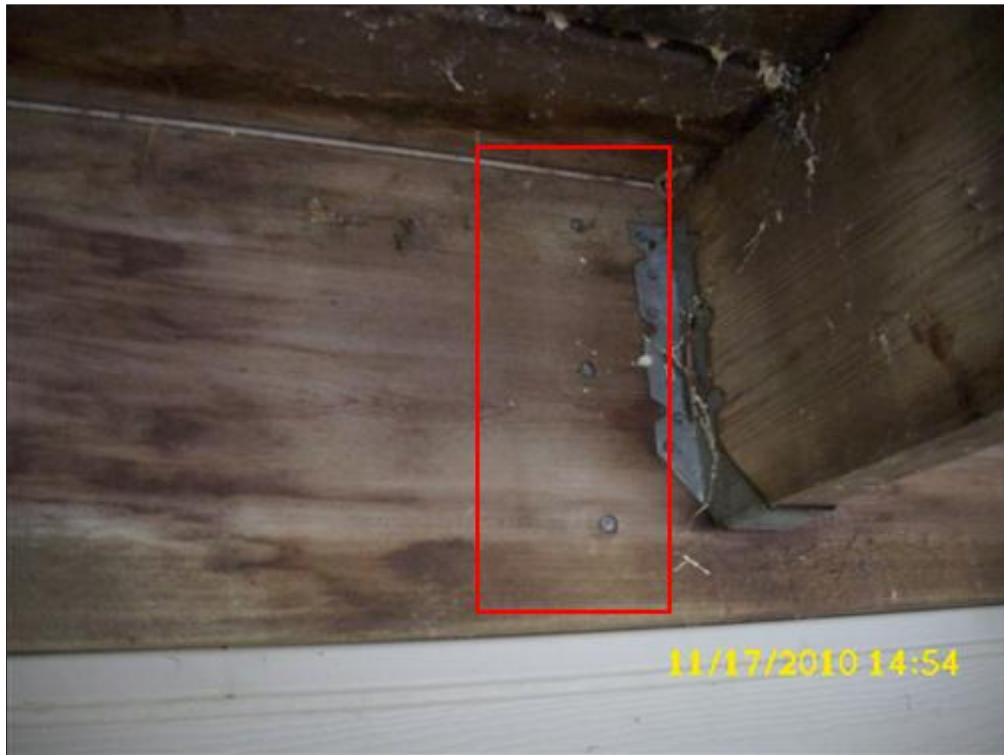
- There are no screws securing the ledger board to the home. This can be an extremely dangerous condition, but is easily repaired. Adding lag screws / bolts or another method to ensure that the structure has adequate support on the house side is necessary.

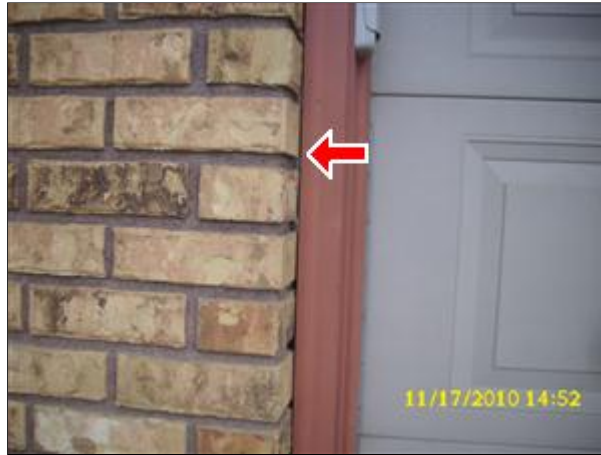
- (2) Gaps between the siding and trim pieces observed. Routine maintenance of caulking all openings is necessary to prevent water entry.

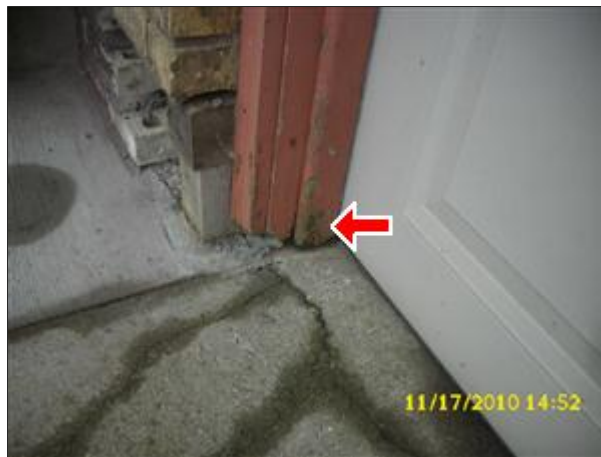
- ☒ (3) Deterioration of the trim materials observed. Suggest monitoring as future repairs or replacement will be necessary.

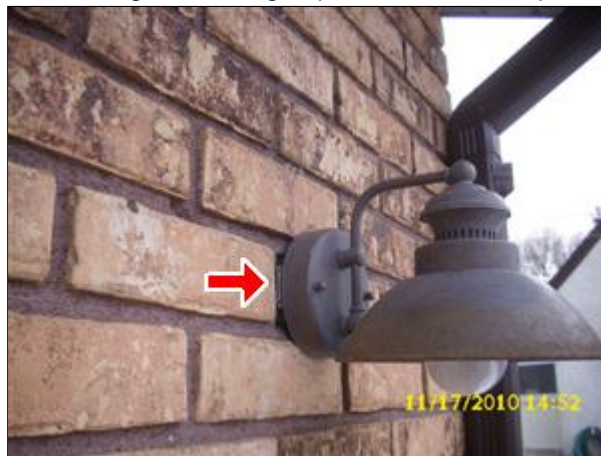
- ☒ (4) Suggest caulking all penetrations through the siding to prevent moisture / pest intrusion.

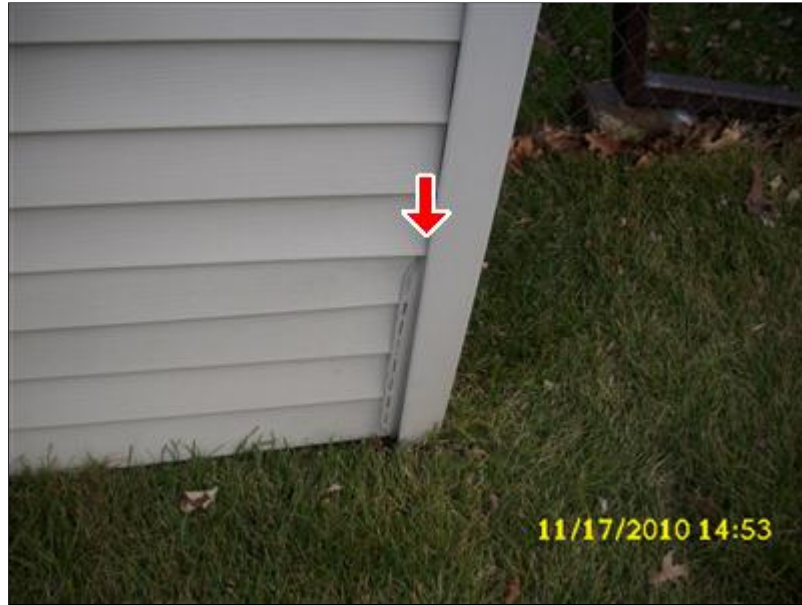
- ☒ (5) Loose pieces of siding/trim observed. Repairs are necessary to prevent water entry.

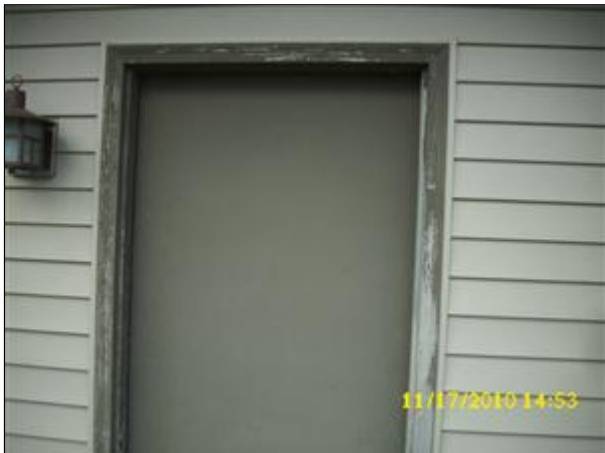
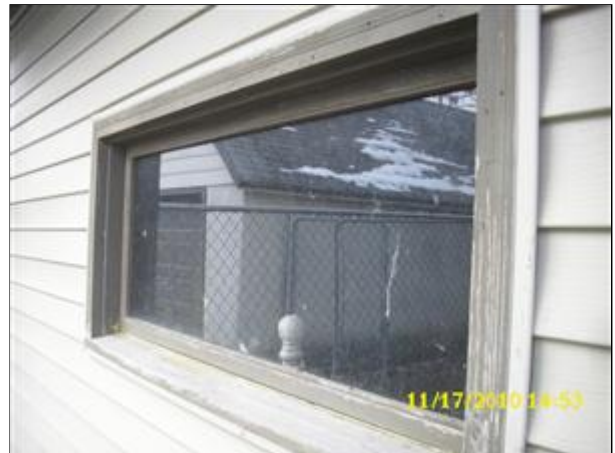
- (6) Deterioration of the paint/stain observed. Re-sealing is necessary to prevent further deterioration.

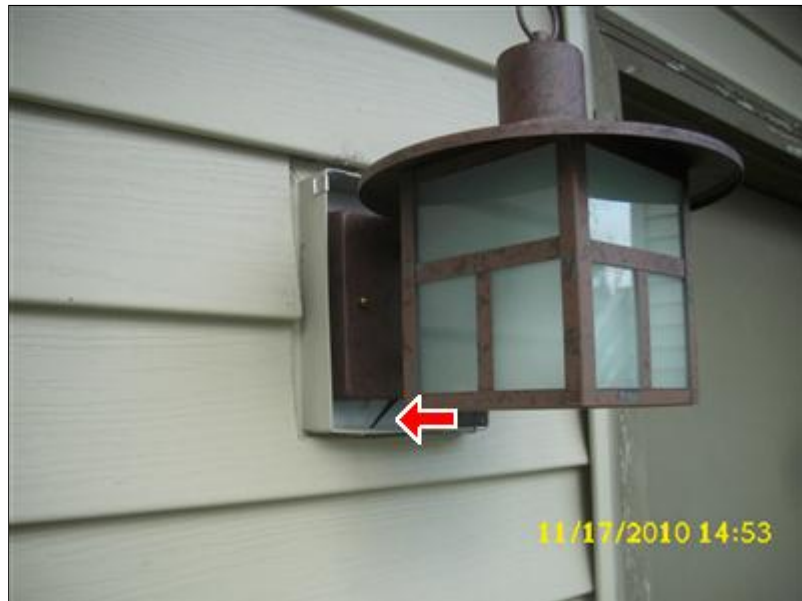
- (7) Missing mounting block observed for light fixture. Suggest correction.

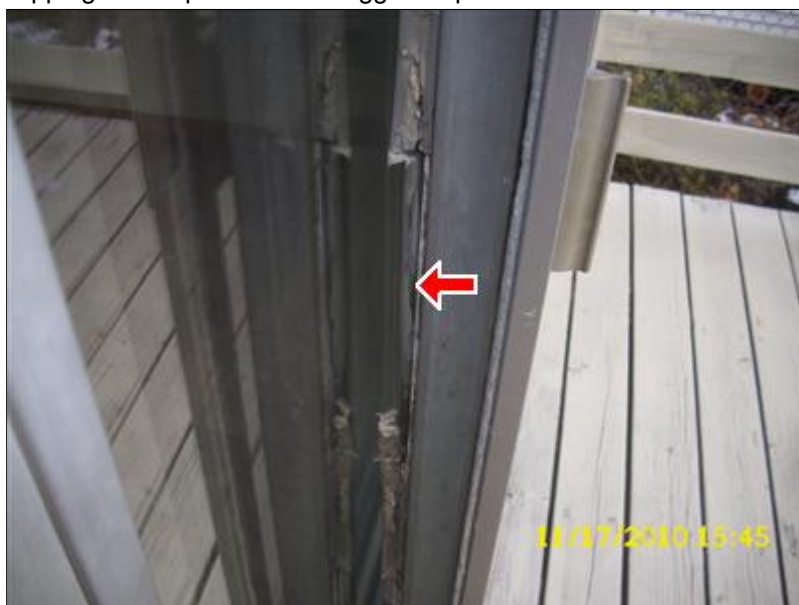
- (4) Damaged weather-stripping on the patio door. Suggest repairs.

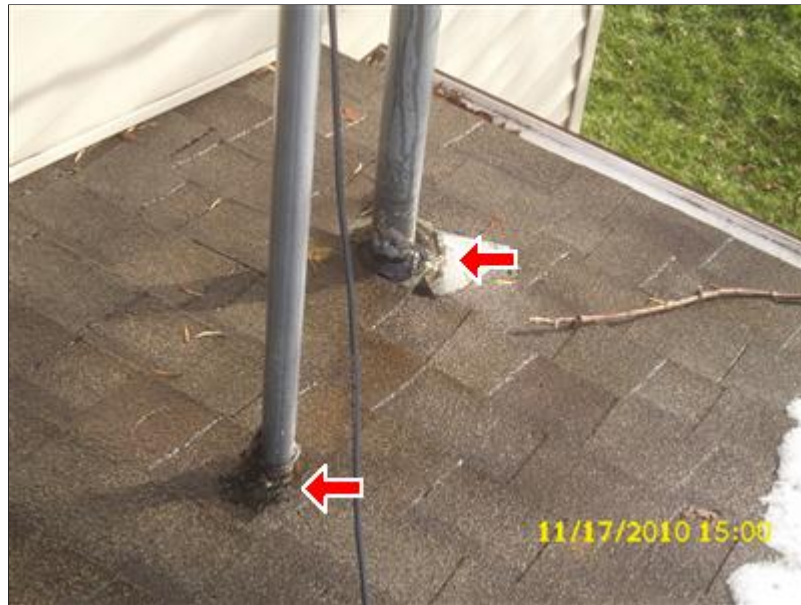
- (2) Patching noted at the electrical service drop and antennae connection. Suggest monitoring as future repairs may be necessary.

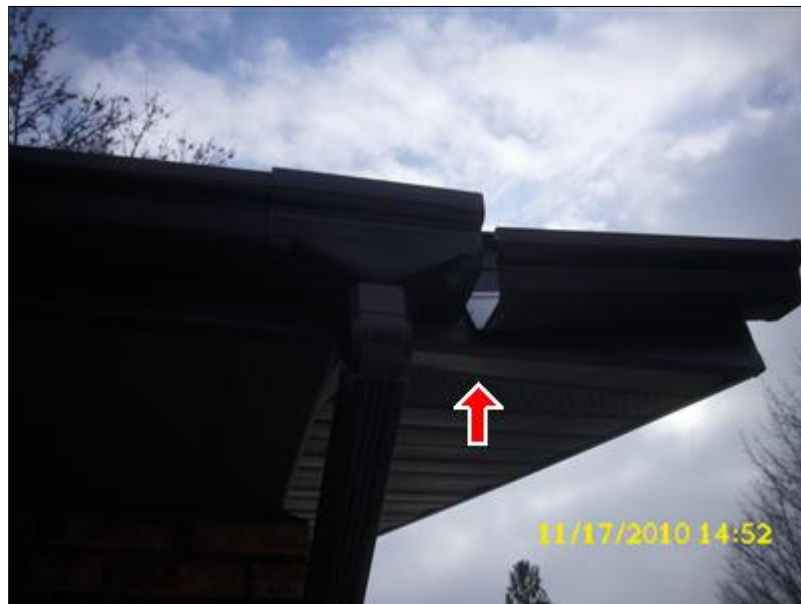
- ☒ (1) Leakage from the gutters observed. Repair or replacement of portions of the gutters is recommended so that they can function as intended.

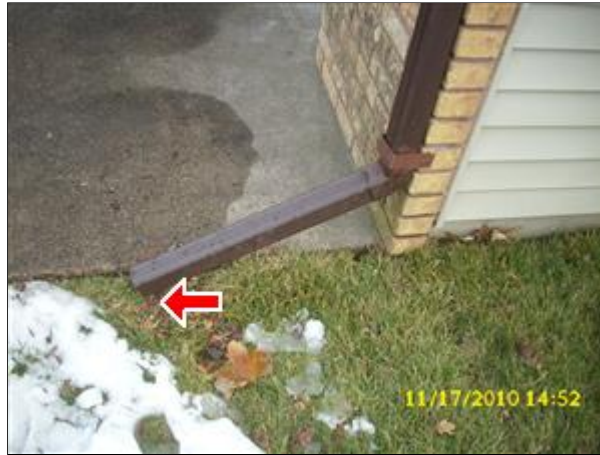
- ☒ (2) Adding extensions to the gutter system is necessary so that roof run off is discharged at least six feet away from the foundation.

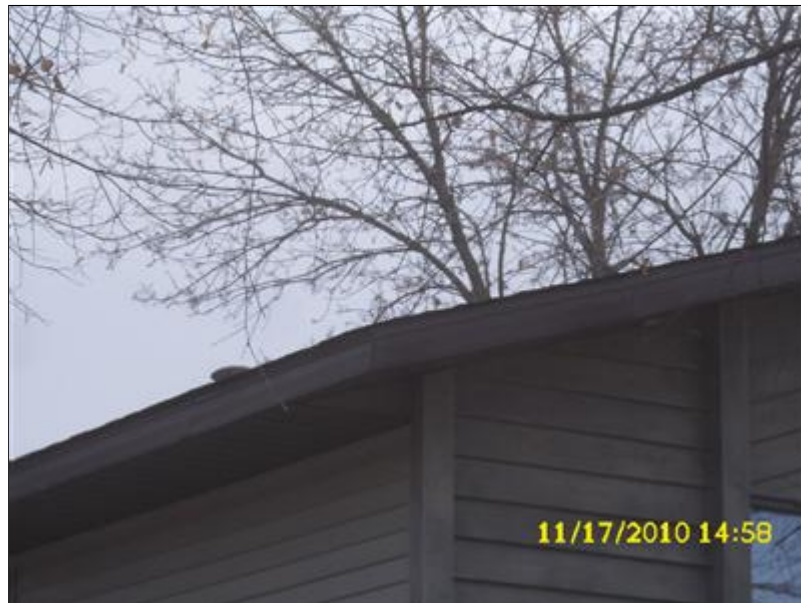
- (1) Due to snow cover we are only able to view a portion of the roof covering. Our comments reflect the areas that were viewed. Verification of its condition by the seller and/or a roofing contractor is recommended.
- (2) Tree branches are rubbing on the roof. Trimming of the branches is necessary to prevent damage to the roof covering.

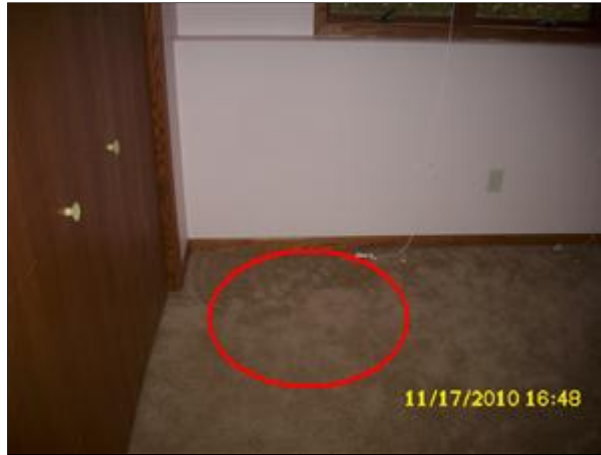
- We are unable to determine if there is a foundation drain system in the home. There is an indentation in the floor, under the carpet in the lower right bedroom. Suggest verification of all conditions be made by the seller.

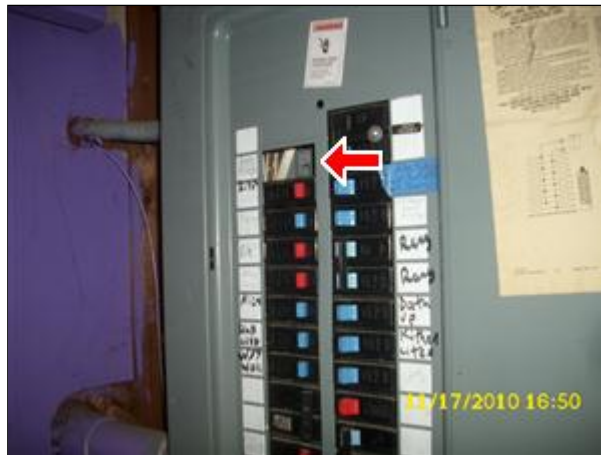
- ☑ Openings in the panel enclosure observed. All unused openings should be capped to prevent access to the interior of the panel and to maintain the fire resistance integrity of the panel.

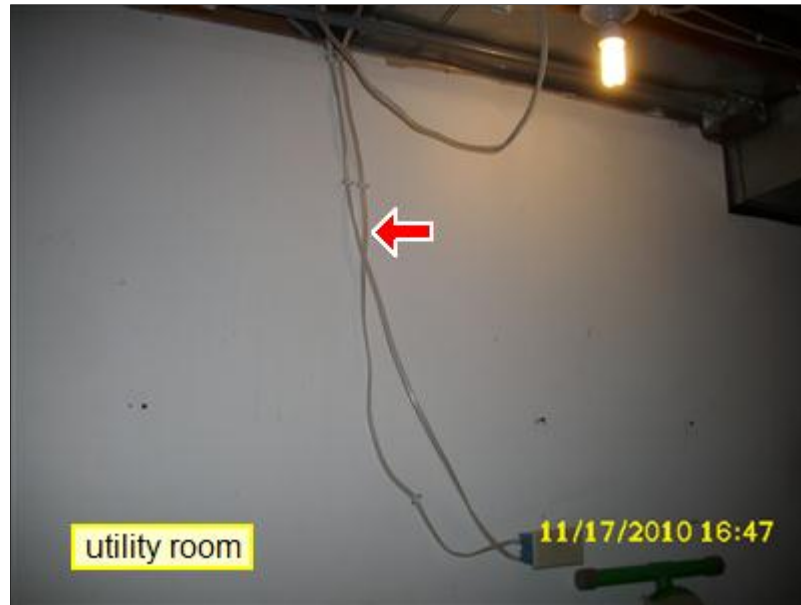
- ☑ (5) Non metallic wiring is not permitted below the ceiling joists without protection and support. Correction is suggested.

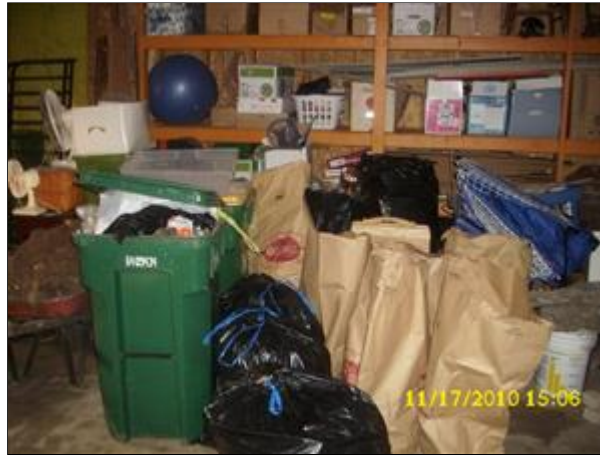
- (3) Due to personal objects stored in the garage not all areas were visible. Verification of all conditions by the seller is necessary.

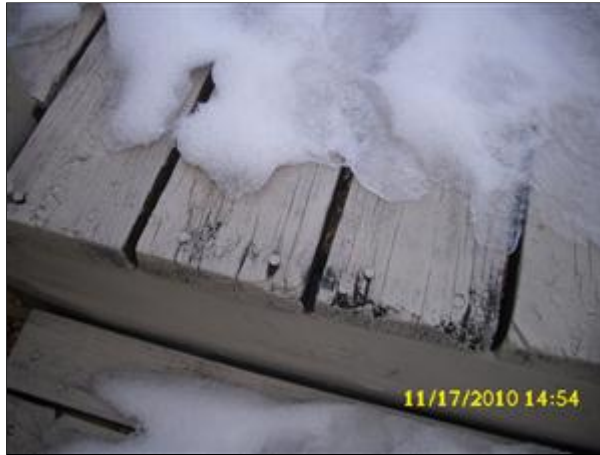
- ☒ Deterioration of the flooring material observed. Future replacement will be necessary.

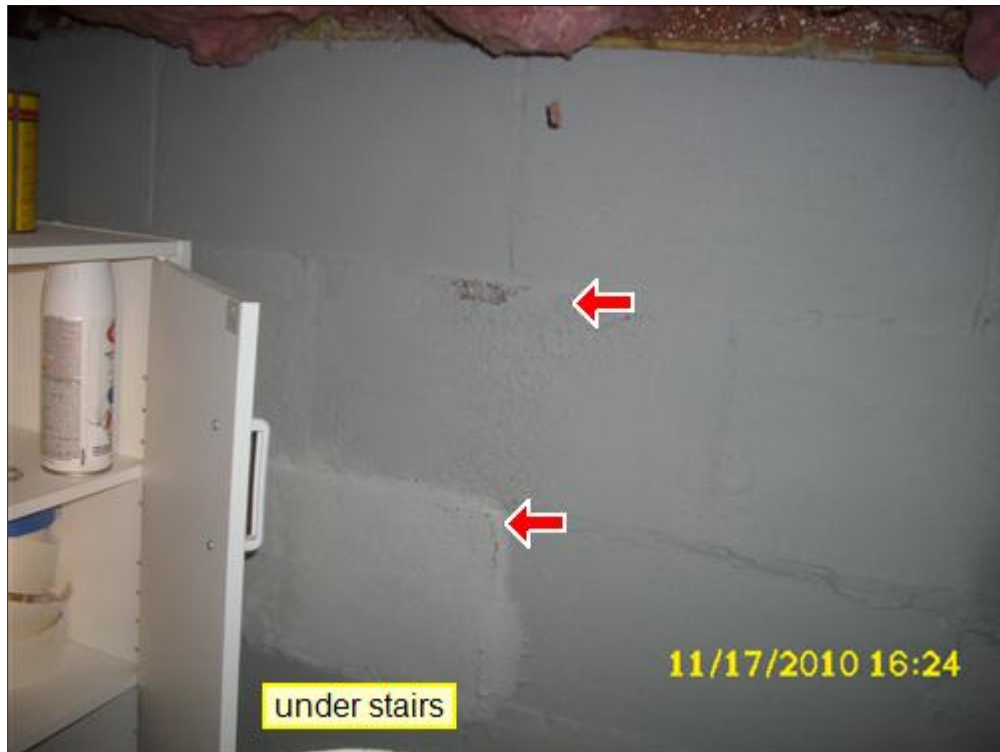
Efflorescence present on the foundation walls. Efflorescence is a white, powdery substance on masonry caused by water-soluble salts leaching to the surface. It is primarily a visual problem and very rarely causes any structural problems. However, the presence of efflorescence indicates that there is a water source or high humidity behind or near the foundation wall that should be eradicated.

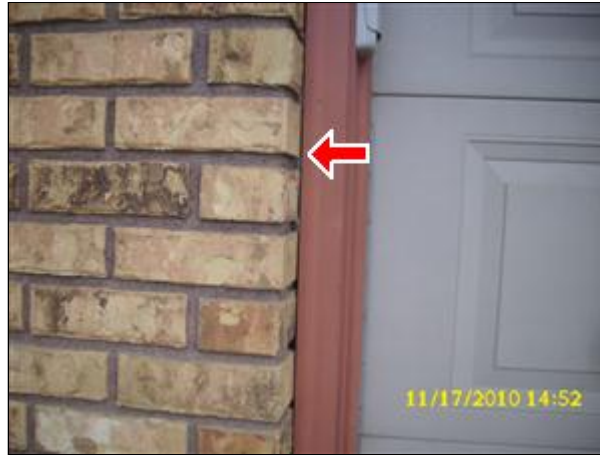
[📷](#) (2) Gaps between the siding and trim pieces observed. Routine maintenance of caulking all openings is necessary to prevent water entry.

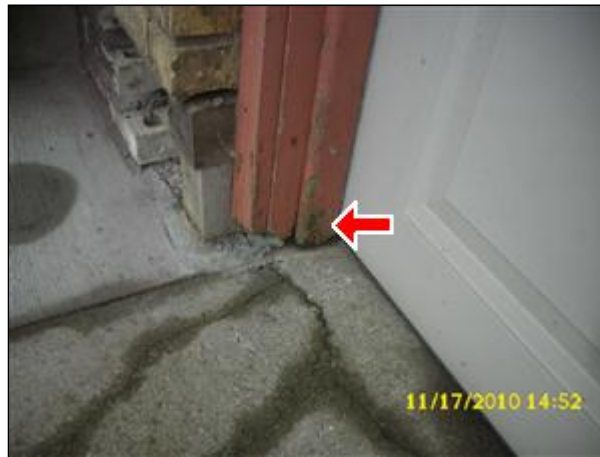
☒ (3) Deterioration of the trim materials observed. Suggest monitoring as future repairs or replacement will be necessary.

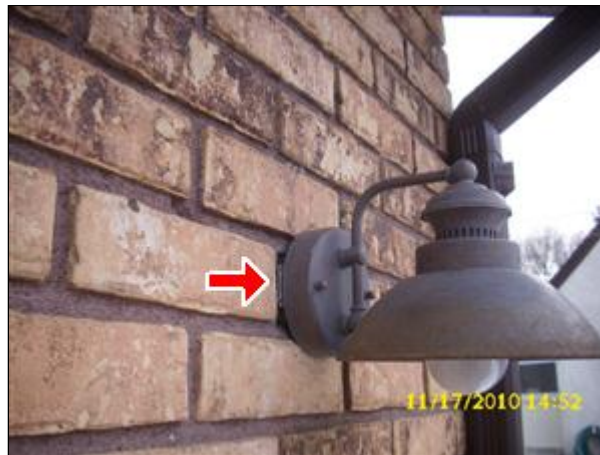
☒ (4) Suggest caulking all penetrations through the siding to prevent moisture / pest intrusion.

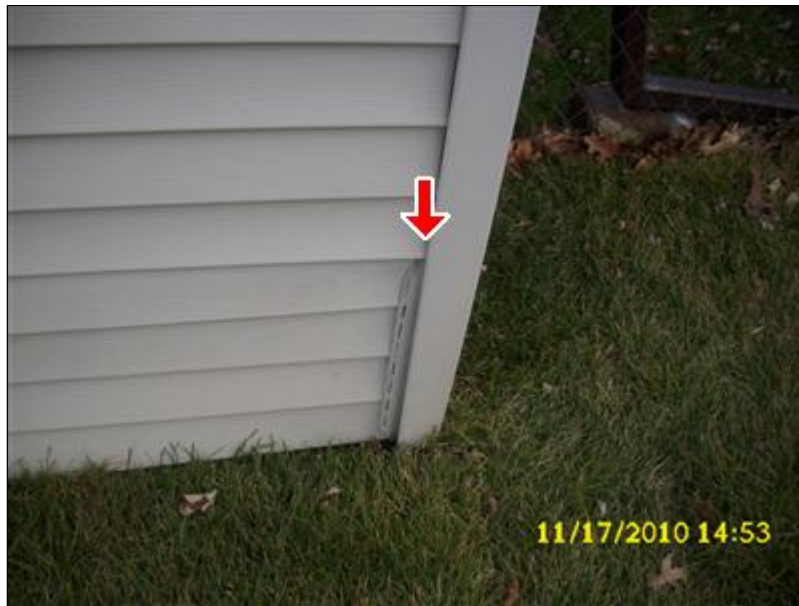
☒ (5) Loose pieces of siding/trim observed. Repairs are necessary to prevent water entry.

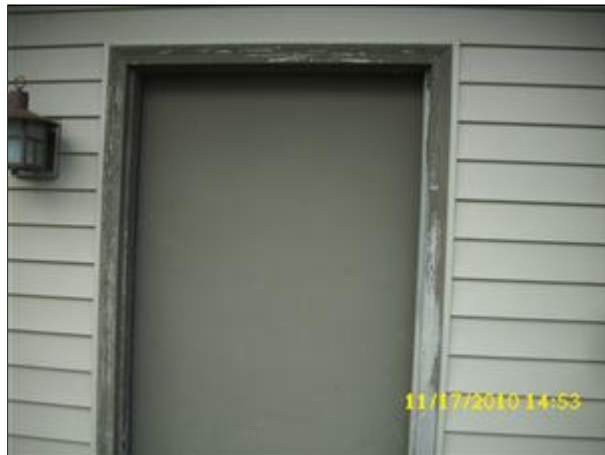
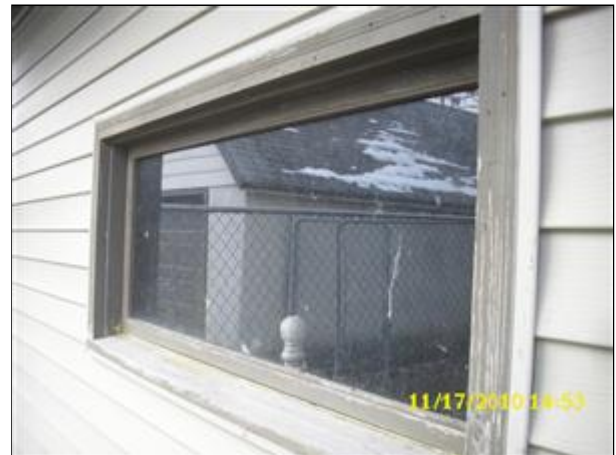
☒ (6) Deterioration of the paint/stain observed. Re-sealing is necessary to prevent further deterioration.

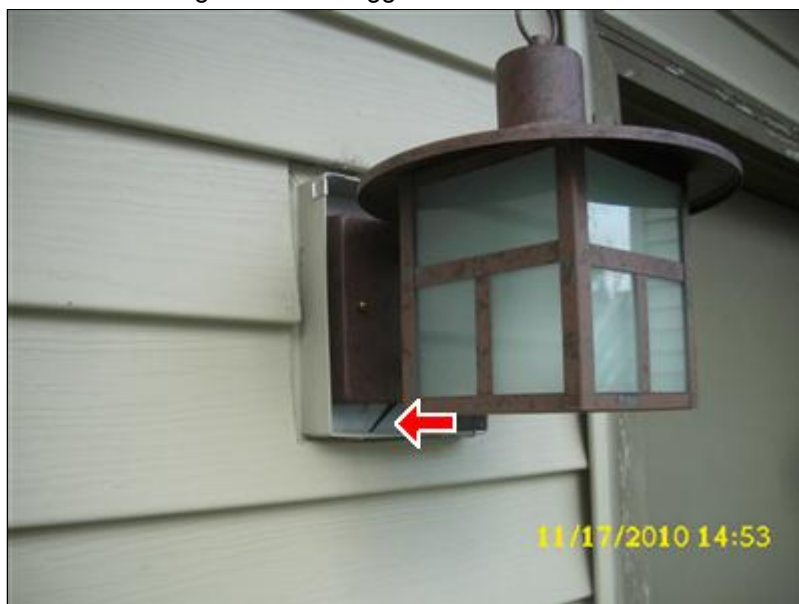
☒ (7) Missing mounting block observed for light fixture. Suggest correction.

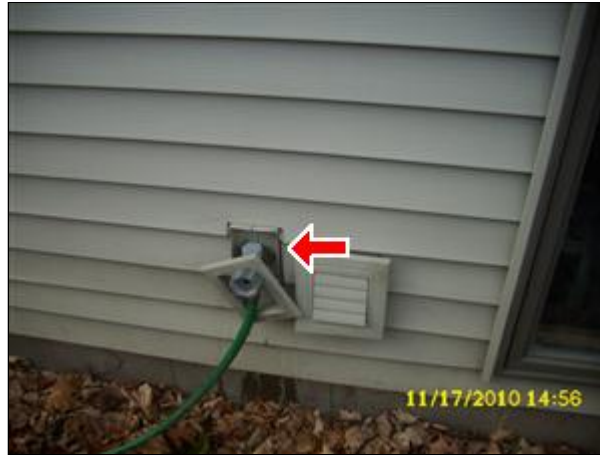
(8) Loose siding block cover noted. Suggest repairs.

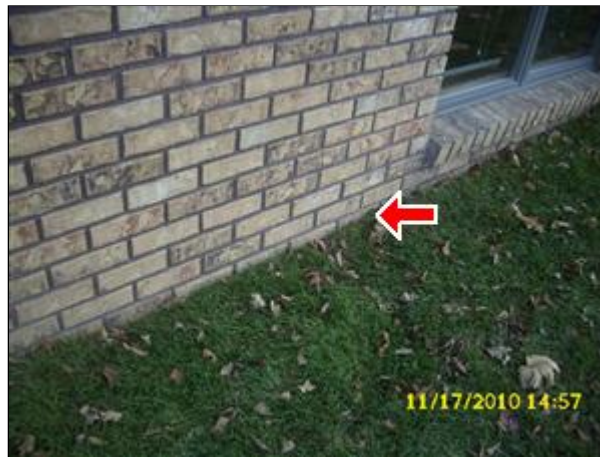
(9) No weep holes observed at the base of the walls. Weep holes are small gaps in the mortar at the base of the wall that allow water that makes it to the interior space a chance to escape. While recommended by most authorities, very seldom are they installed. The installation will involve removal of the siding material.

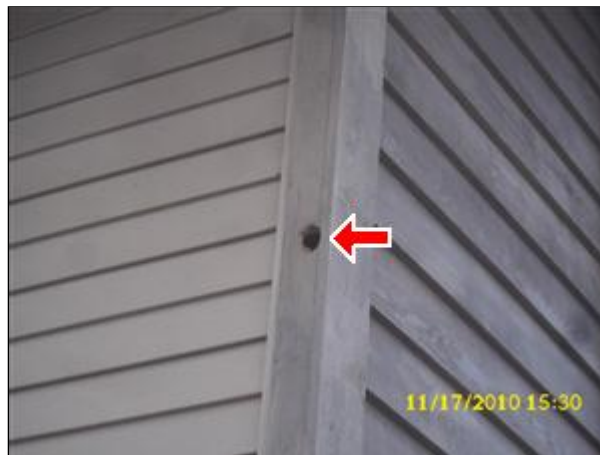
(10) Damage from woodpeckers is observed on the siding/trim. Patching the damaged areas and efforts to deter woodpeckers from returning is recommended.

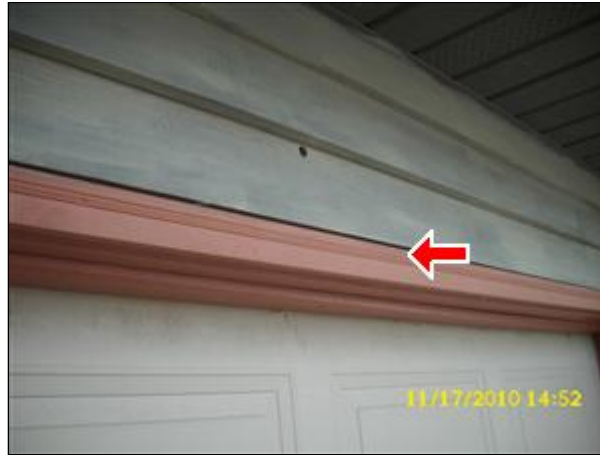
(1) Missing flashing noted over the doors. Suggest repairs.

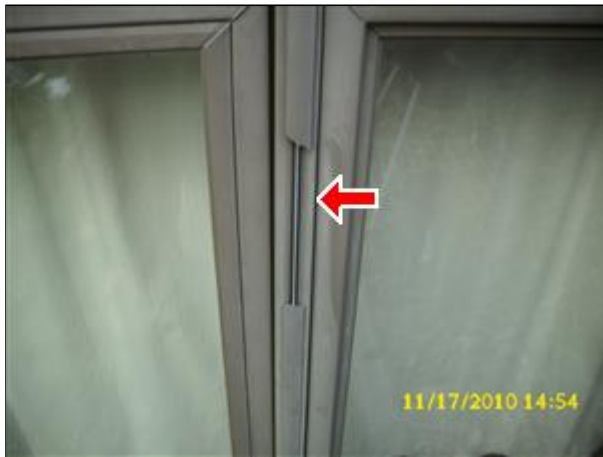
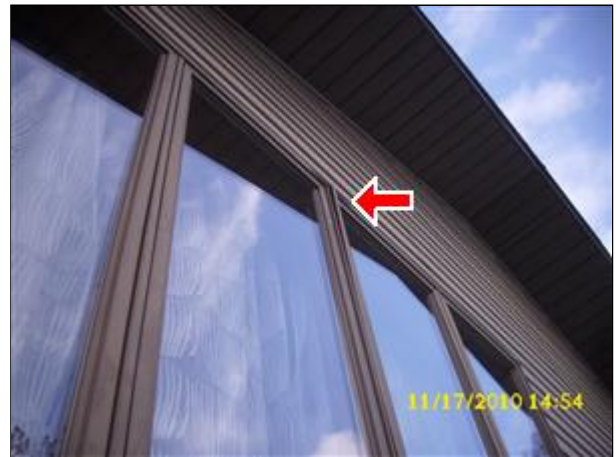
❌ (2) Missing / damaged window mull covers observed on the exterior. Repairs are necessary to prevent water intrusion.

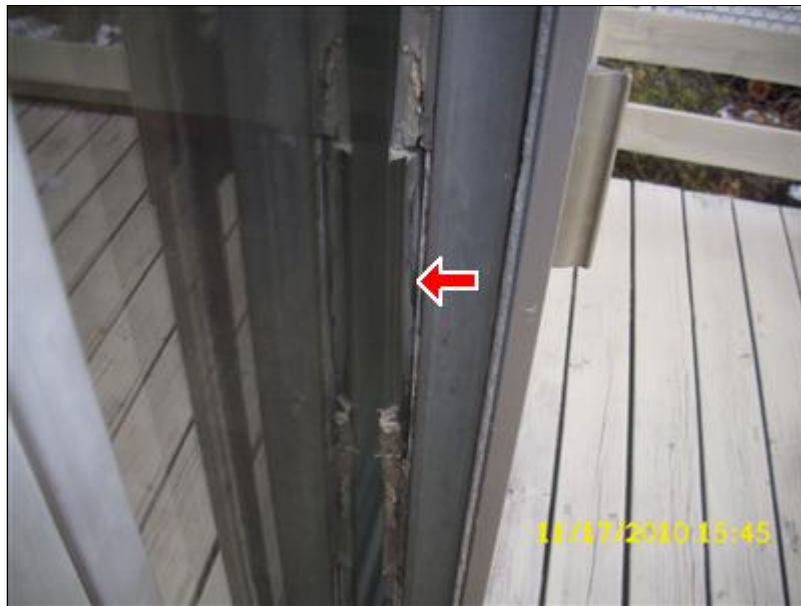
⊠ (4) Damaged weather-stripping on the patio door. Suggest repairs.

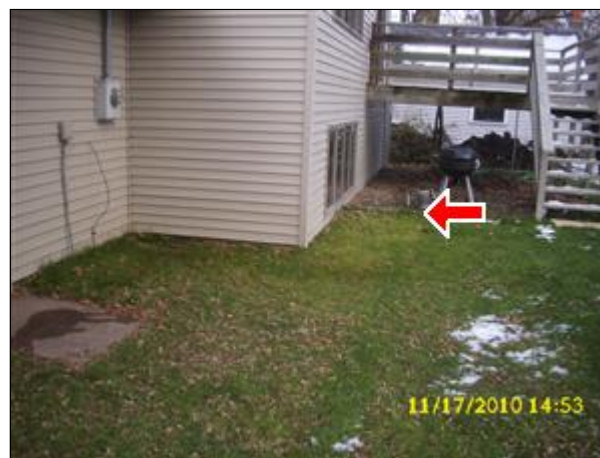
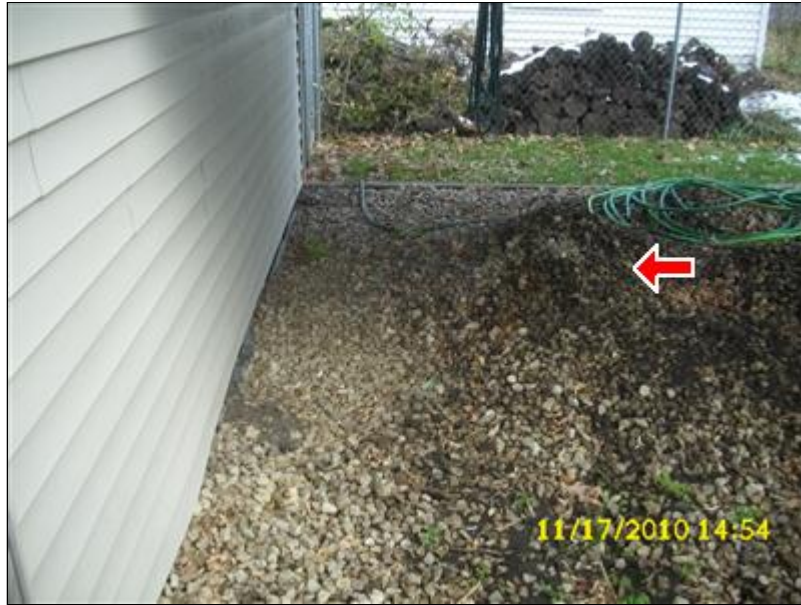
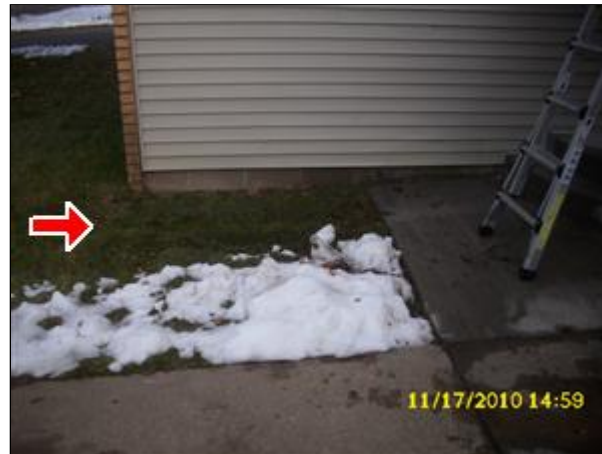
- The ground around the building slopes directly towards the building. This will result in water pooling next to the foundation leading to other problems. A slope of at least one inch drop per foot away from the building for at least the first six feet is advised.

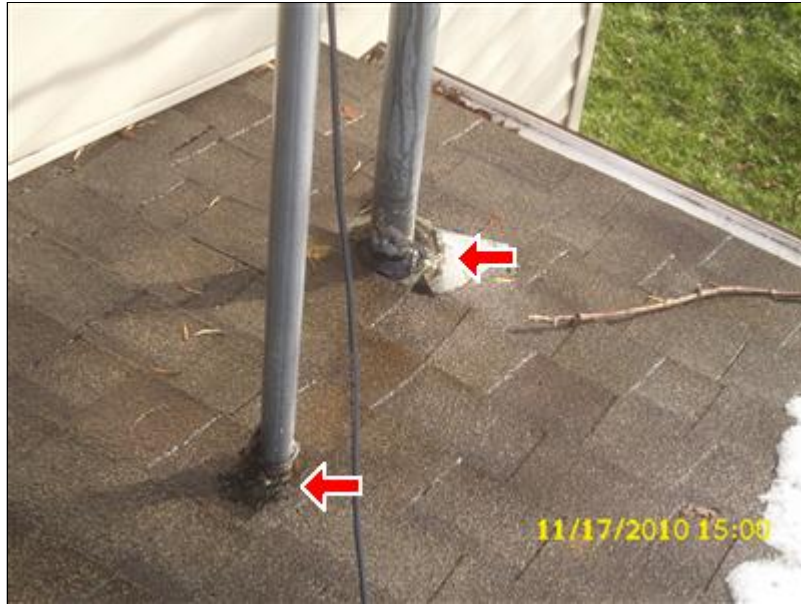
- ⏏ (2) Patching noted at the electrical service drop and antennae connection. Suggest monitoring as future repairs may be necessary.

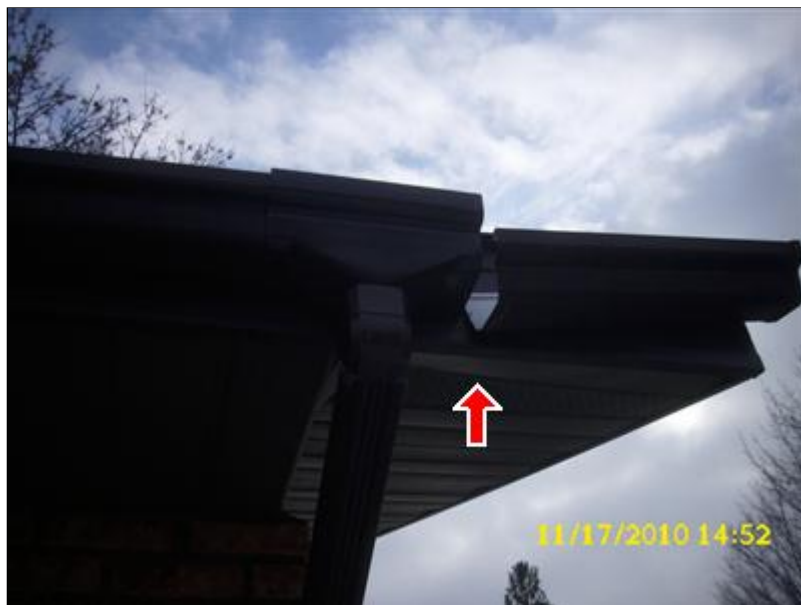
- ⏏ (1) Leakage from the gutters observed. Repair or replacement of portions of the gutters is recommended so that they can function as intended.

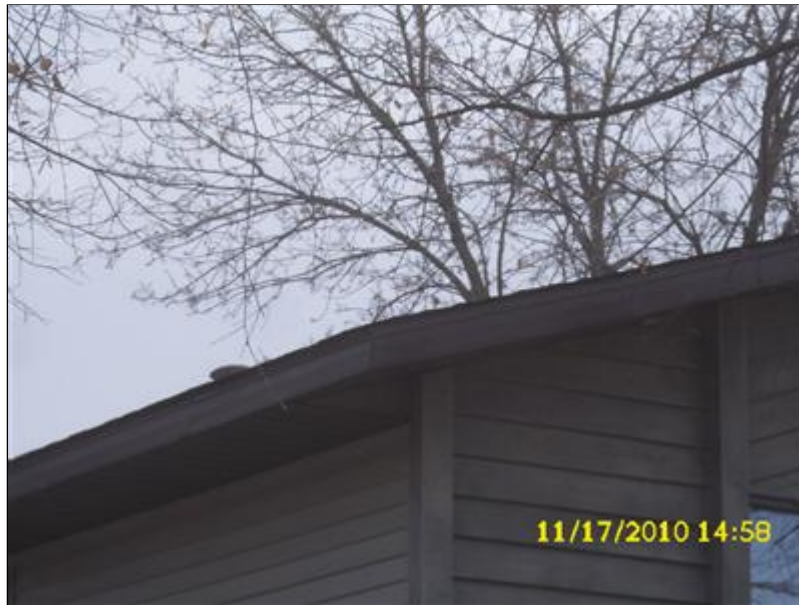
- ☒ (1) Due to snow cover we are only able to view a portion of the roof covering. Our comments reflect the areas that were viewed. Verification of its condition by the seller and/or a roofing contractor is recommended.
- ☒ (2) Tree branches are rubbing on the roof. Trimming of the branches is necessary to prevent damage to the roof covering.

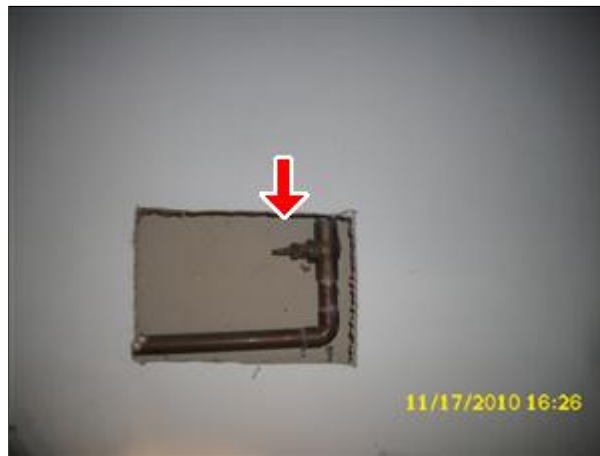
Missing handle for exterior water shut off valve.
