Minnesota Home Inspectors

Inspection Report

Property Address:

Any Street

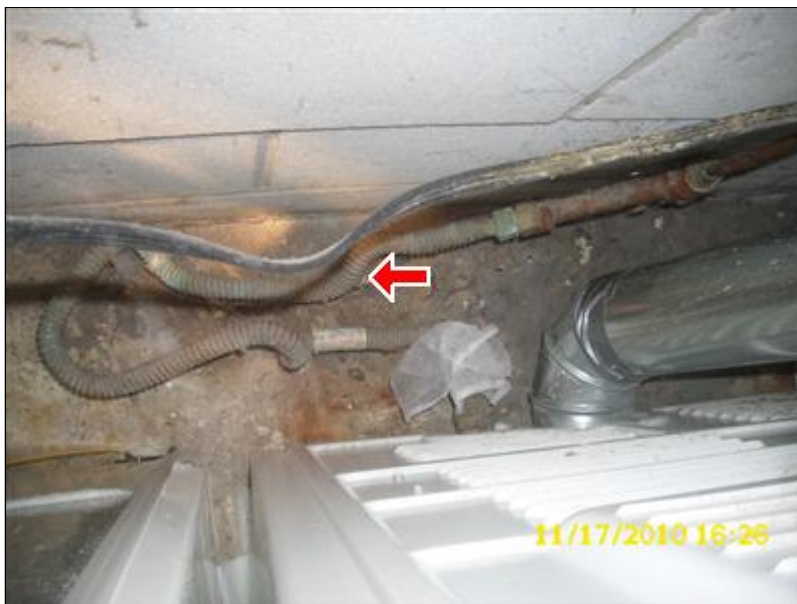
- The flexible gas lines used at the dryer connection are no longer approved by the American Gas Association. Due to concerns with pin hole leaks in the connectors replacement with approved connectors is recommended.

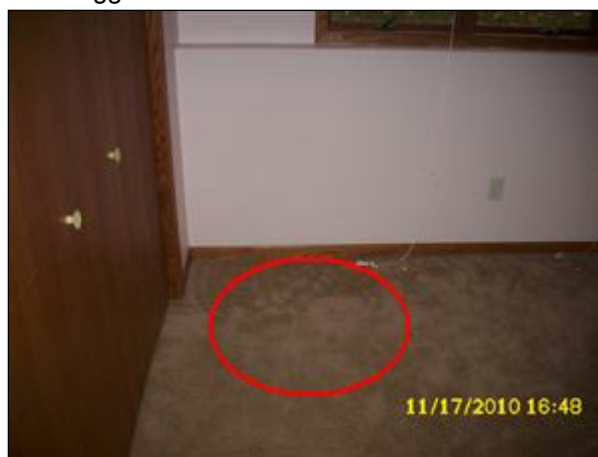
- We are unable to determine if there is a foundation drain system in the home. There is an indentation in the floor, under the carpet in the lower right bedroom. Suggest verification of all conditions be made by the seller.

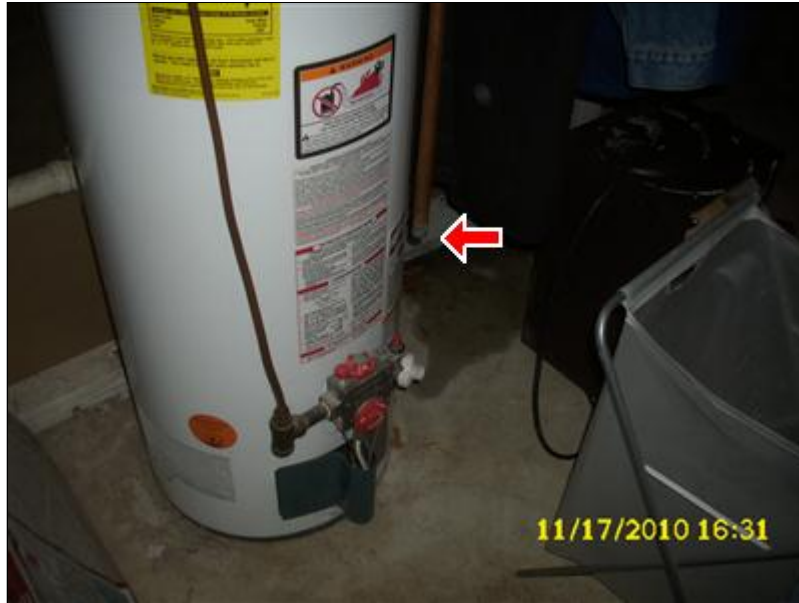
- The extension for the pressure relief valve is improper. This is an important safety device that will direct any water released from the pressure relief valve to a safe area. This extension should be no less than three-quarters of an inch inside diameter, terminate within six inches of the floor, self draining, and not be threaded on the end.

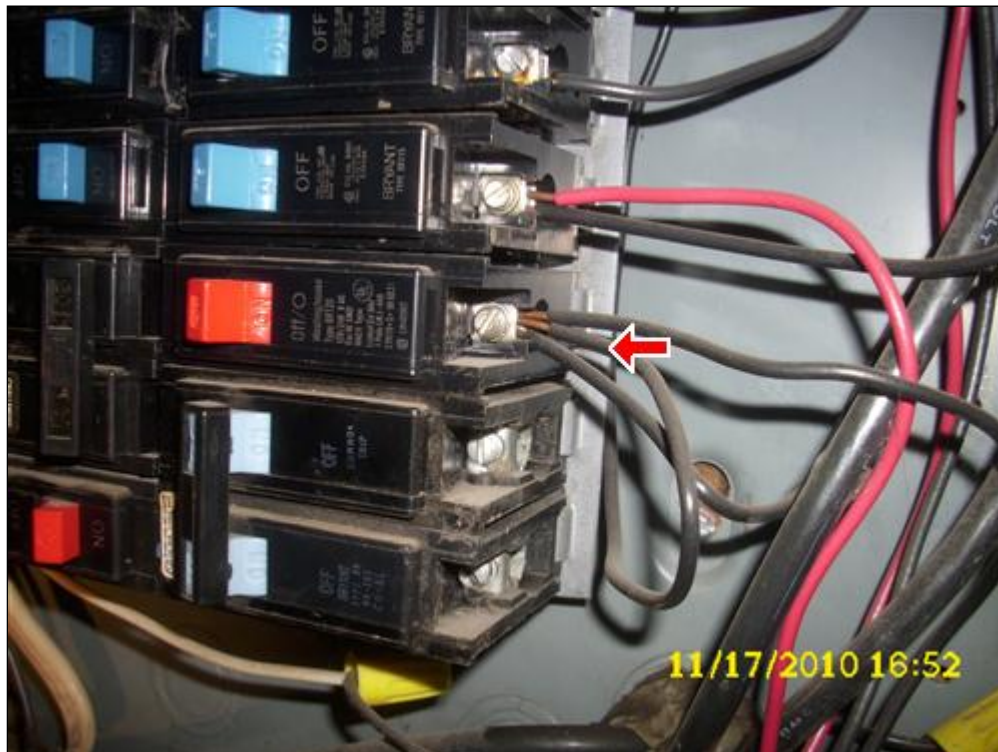
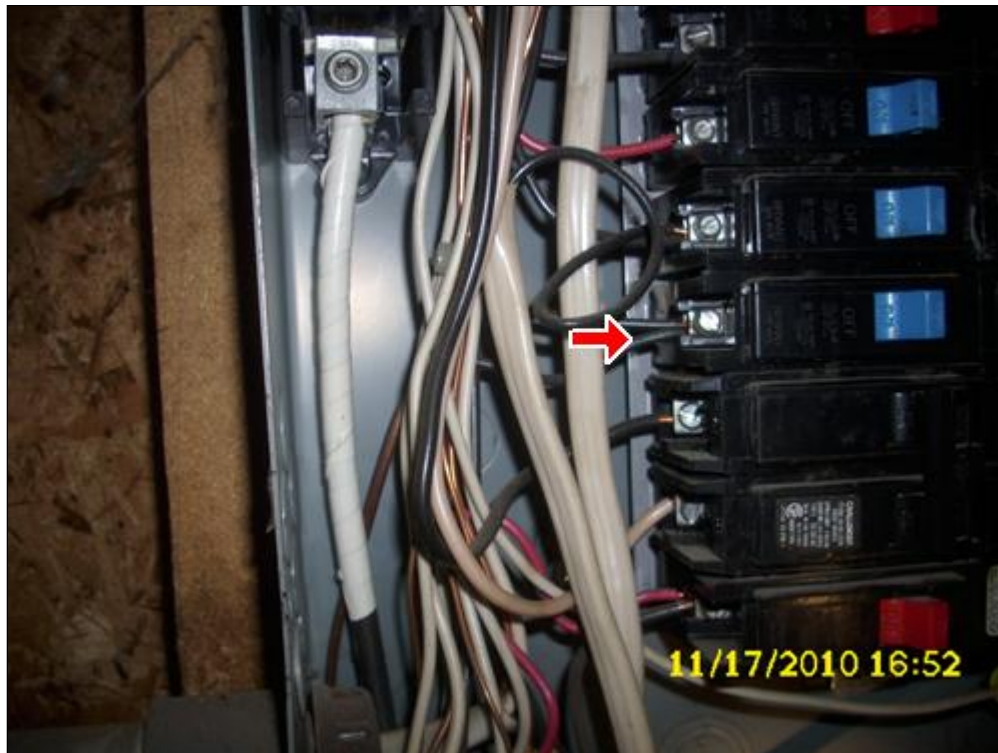
- ☒ (2) More than one wire is observed at individual electrical disconnects. Manufacturer requirements dictate that only one wire is to be connected to this type of disconnect. Repair by a licensed electrician is necessary.

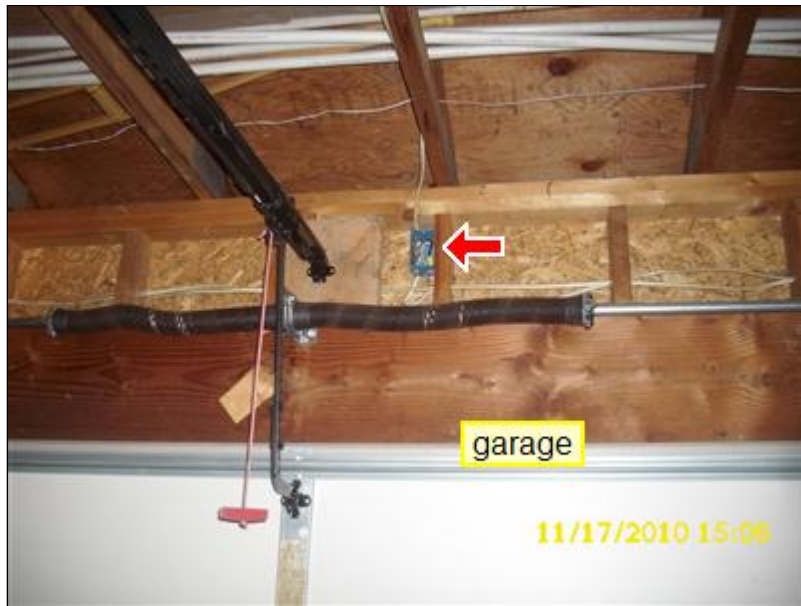
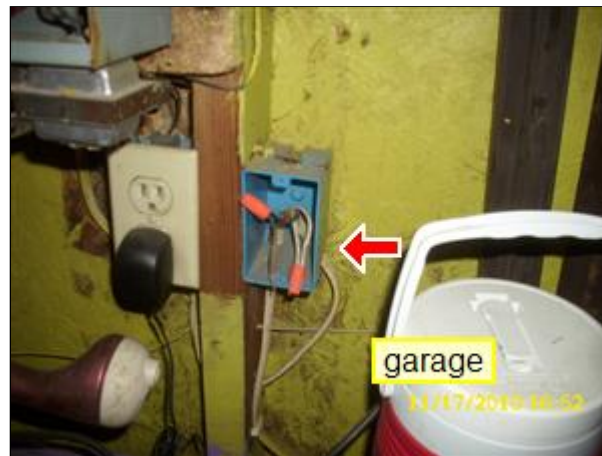
- ❌ (2) Open electrical junction boxes observed. All junction boxes should be sealed with an approved cover for safety.

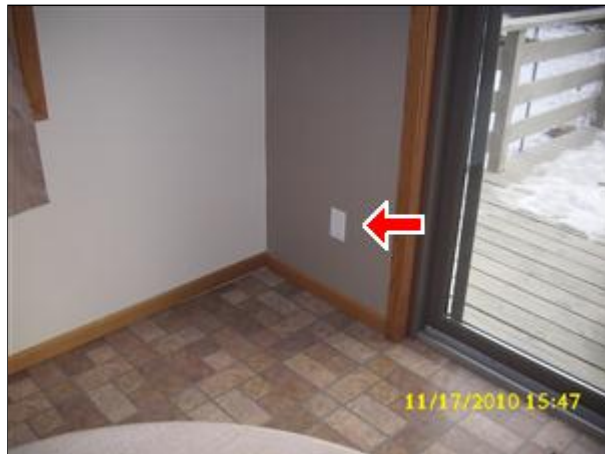
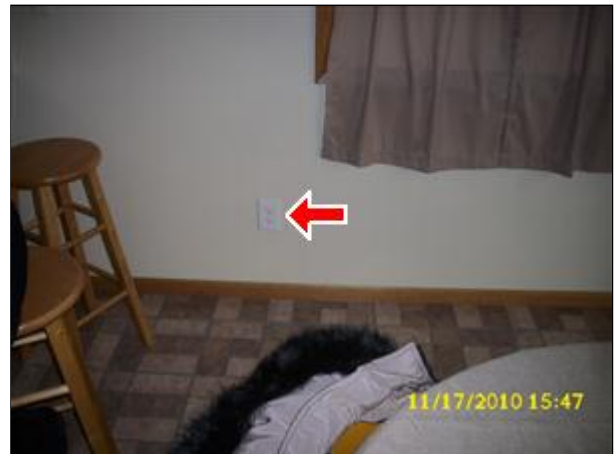
☒ (3) Inoperable outlets observed in the dining room. Review and repair by a qualified electrician is necessary.

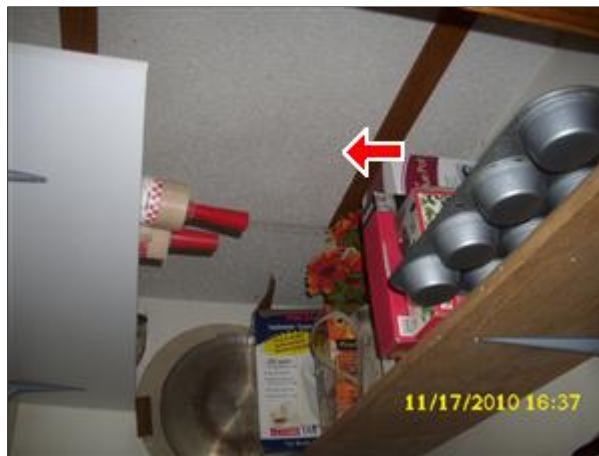
The attic access is blocked by personal items. We suggest verification of all conditions in the attic be done by the seller.

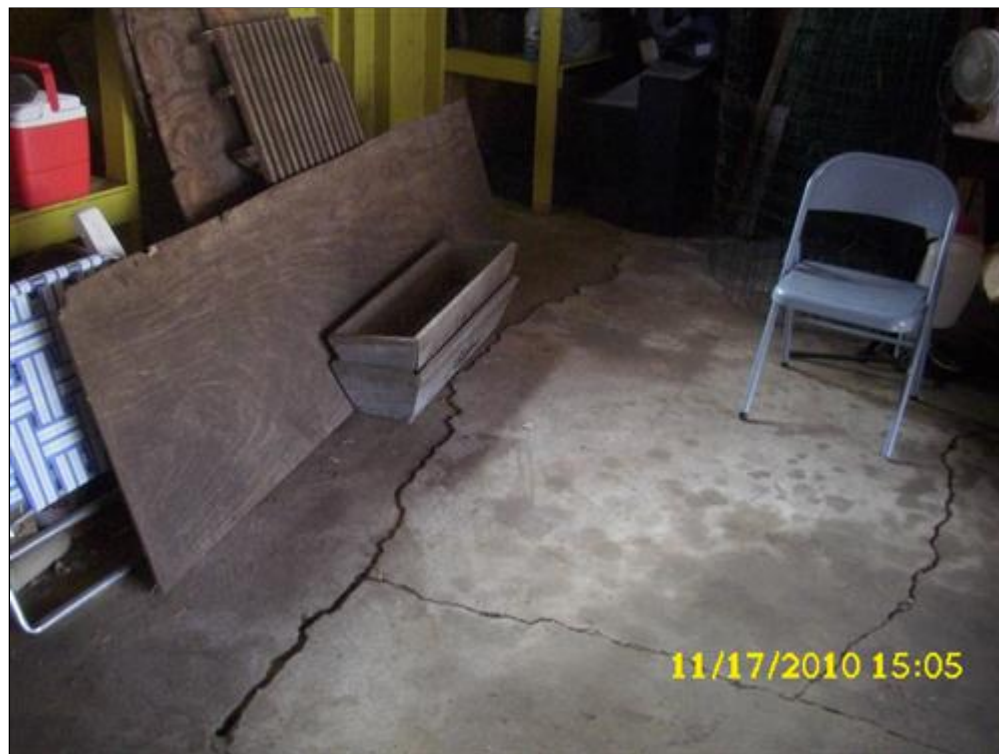
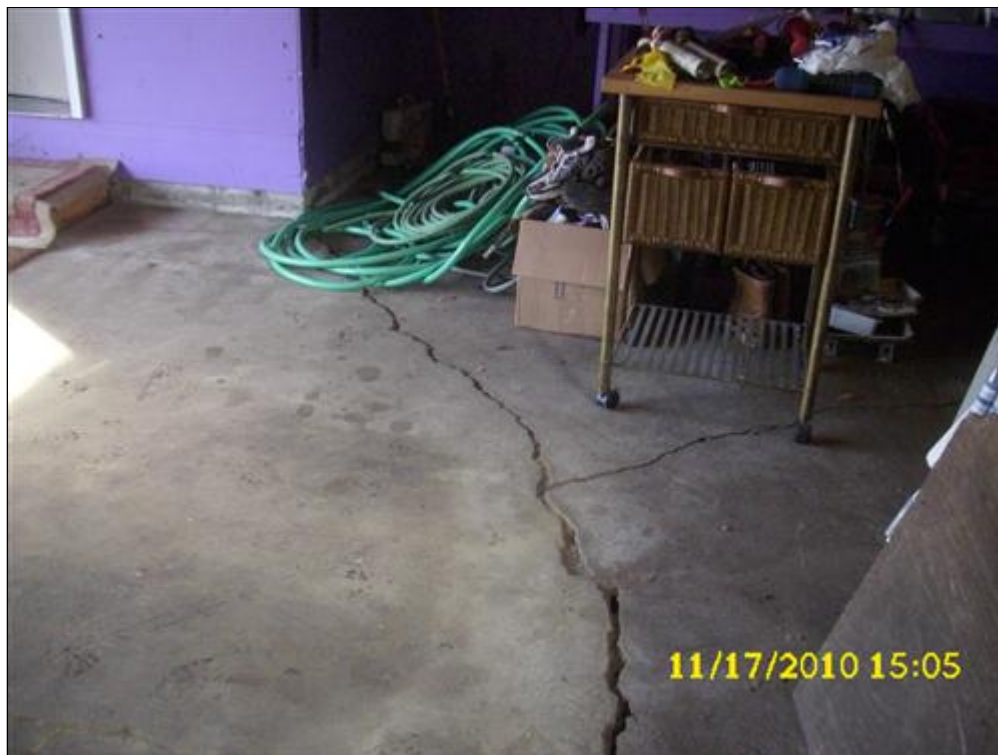
- Heaving of the garage floor observed. This usually indicates problems in the sub-surface area below the slab. Although primarily cosmetic, this can be an indication of structural problems and further review by a qualified contractor is necessary.

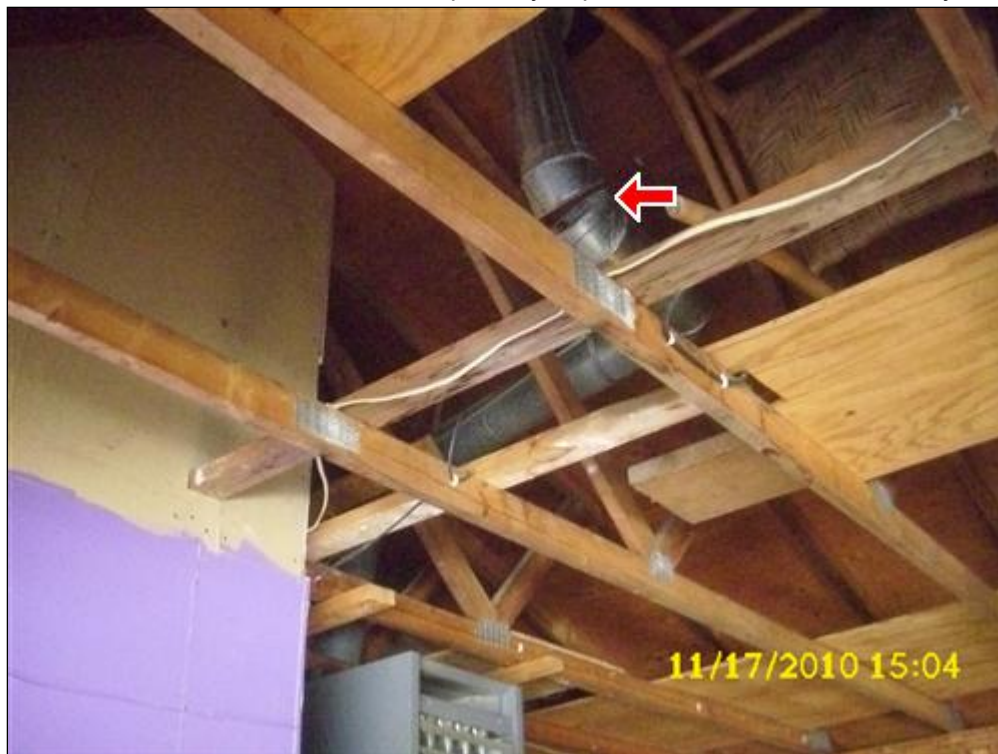
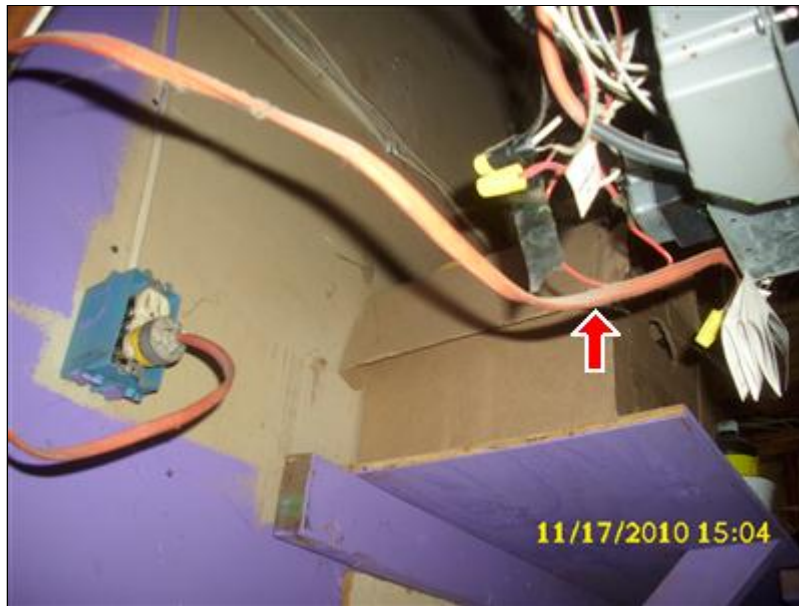
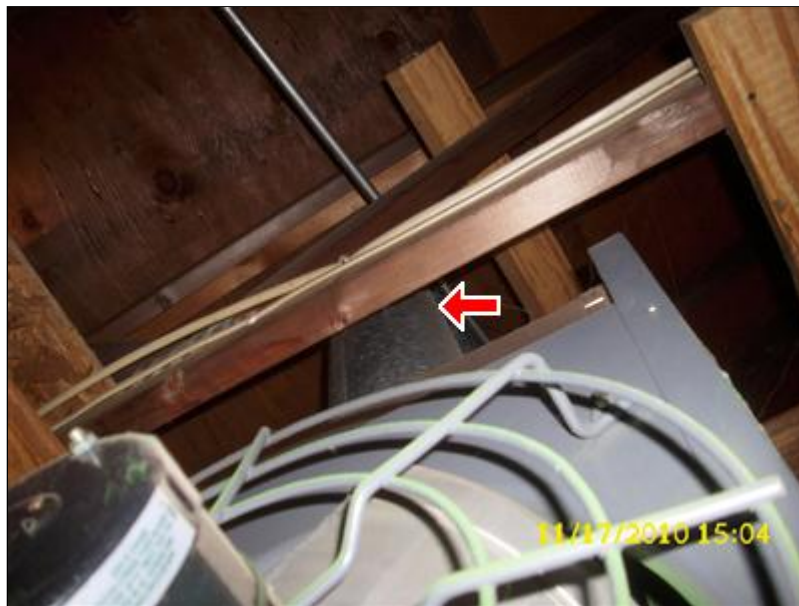
- ☒ (1) The garage heater is improperly installed. Disconnected vent pipe, the vent is too near combustibles, and the electrical wiring is a cut extension cord. Review and repairs by a qualified technician is necessary.

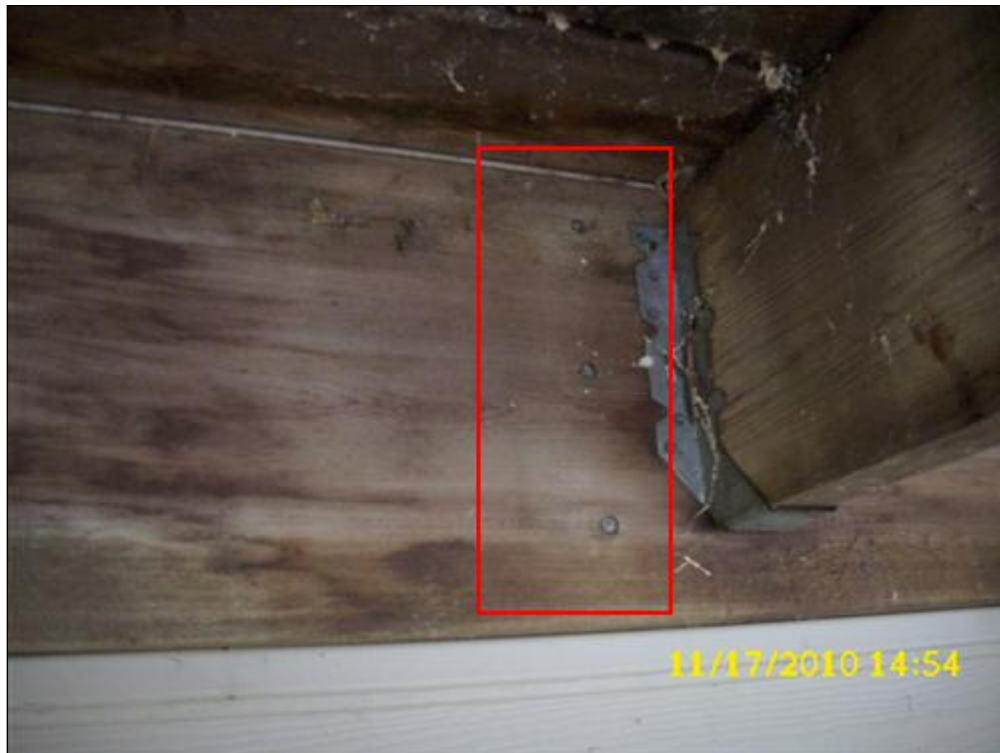
There are no screws securing the ledger board to the home. This can be an extremely dangerous condition, but is easily repaired. Adding lag screws / bolts or another method to ensure that the structure has adequate support on the house side is necessary.
