Minnesota Home Inspectors

Inspection Report

Property Address:

Any Street

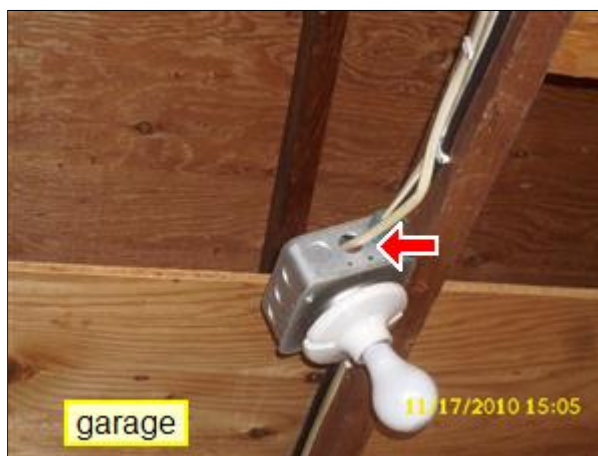
- ☒ (1) Not all of the electrical wiring is protected by stress clamps where it enters junction boxes. Stress clamps are necessary to prevent chafing of the wires which can lead to an electrical short or fire.

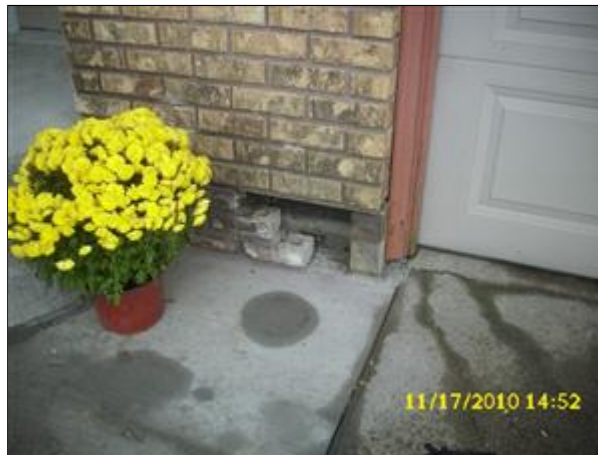
- (1) Missing bricks. Suggest repairs.

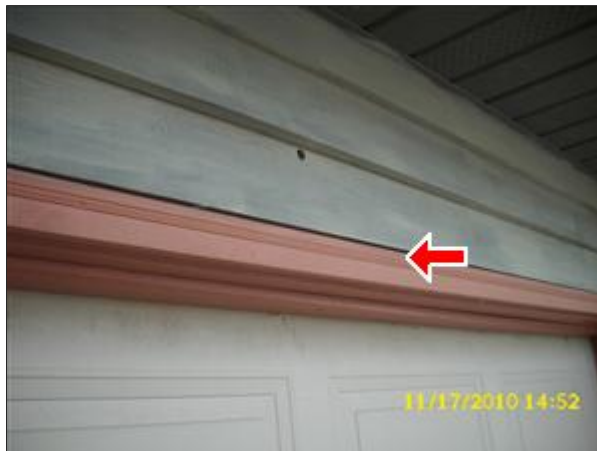
- (1) Missing flashing noted over the doors. Suggest repairs.

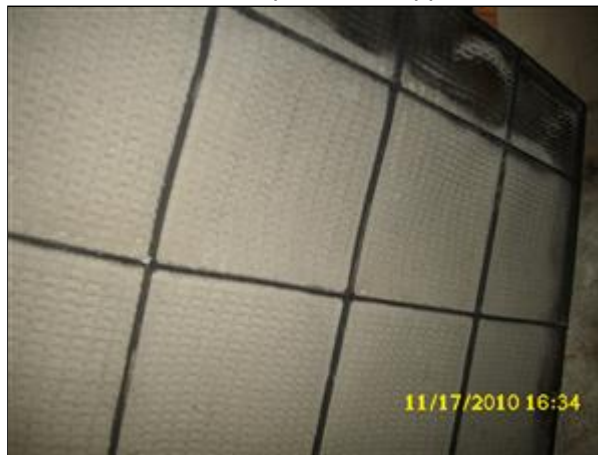
- The filter is in need of changing. An excessively dirty filter will increase the strain on the furnace, decrease the efficiency of the unit, and can lead to a shortened life span of the appliance.

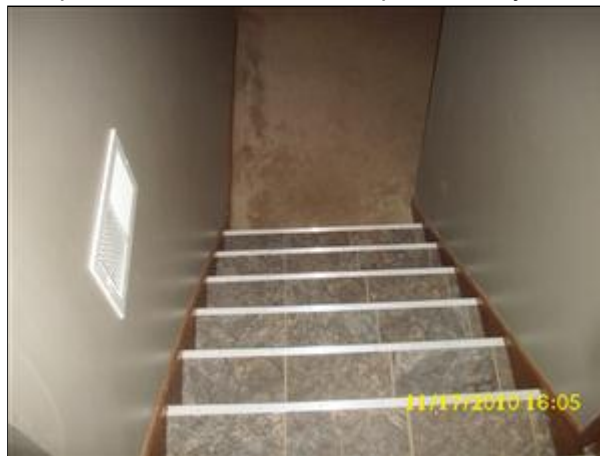
- ☒ (2) A handrail is necessary on all steps with more than three steps for safety.

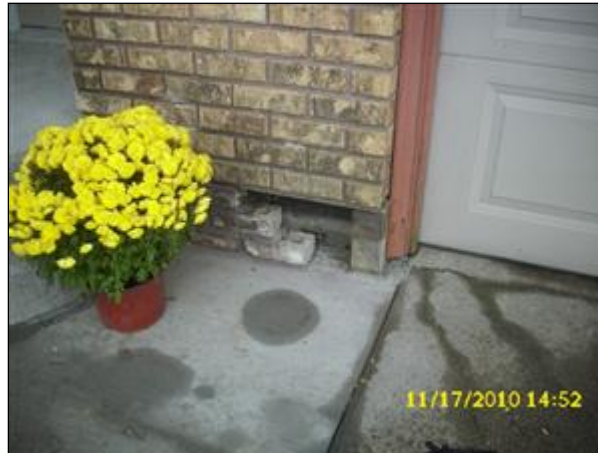
[📷](#) (1) Missing bricks. Suggest repairs.

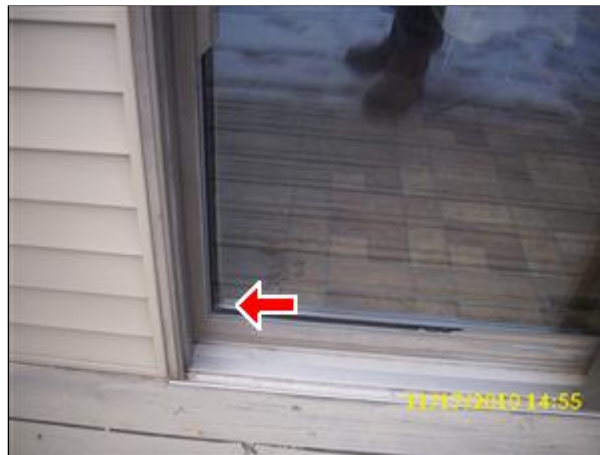
❌ (3) Missing glass stops observed on the patio door. Replacement is necessary to prevent water intrusion and to prevent the glass from falling out.

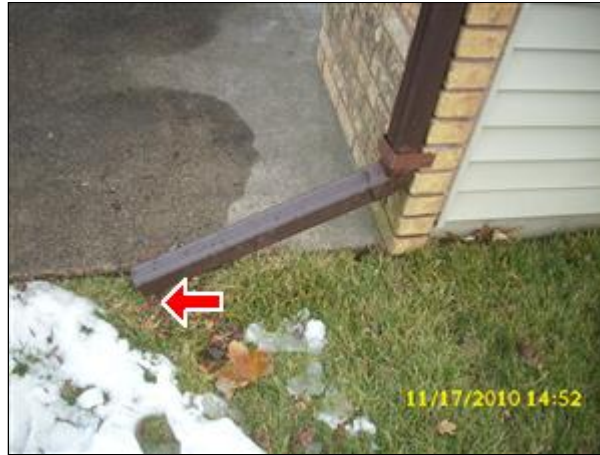
- ⏏ (2) Adding extensions to the gutter system is necessary so that roof run off is discharged at least six feet away from the foundation.

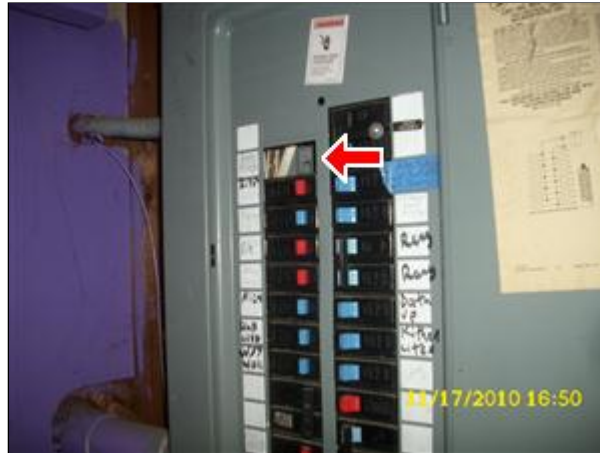
- ☒ Openings in the panel enclosure observed. All unused openings should be capped to prevent access to the interior of the panel and to maintain the fire resistance integrity of the panel.

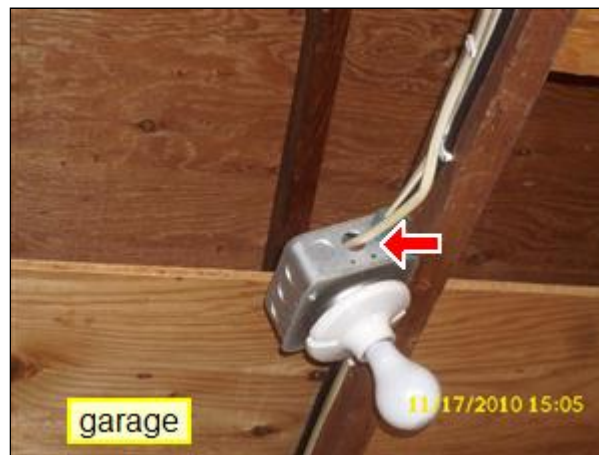
- ❌ (1) Not all of the electrical wiring is protected by stress clamps where it enters junction boxes. Stress clamps are necessary to prevent chafing of the wires which can lead to an electrical short or fire.

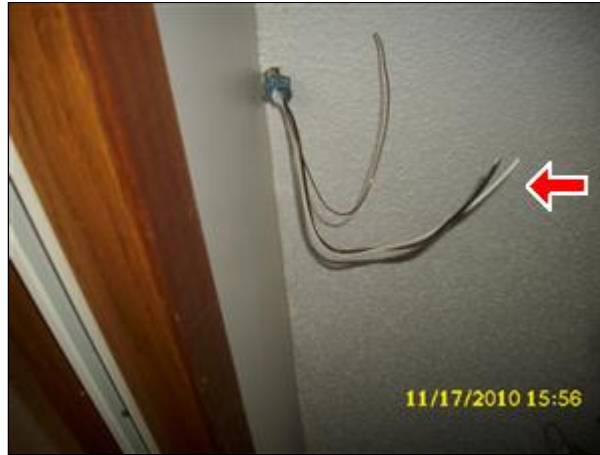
☒ (4) Missing light fixture in the upper left bedroom closet. Repairs are necessary.

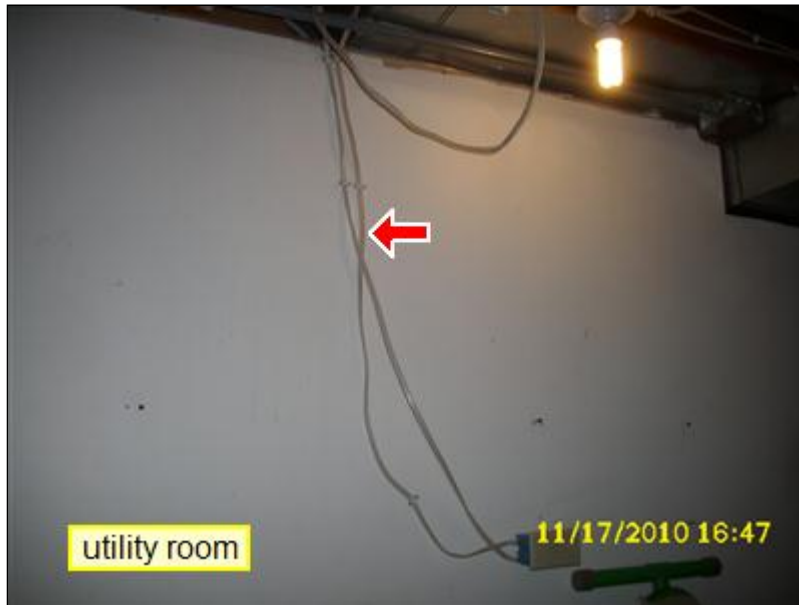
⚠ (5) Non metallic wiring is not permitted below the ceiling joists without protection and support. Correction is suggested.

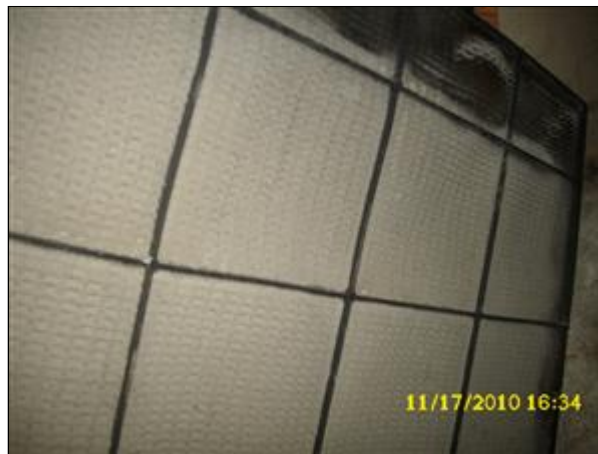
☒ The filter is in need of changing. An excessively dirty filter will increase the strain on the furnace, decrease the efficiency of the unit, and can lead to a shortened life span of the appliance.

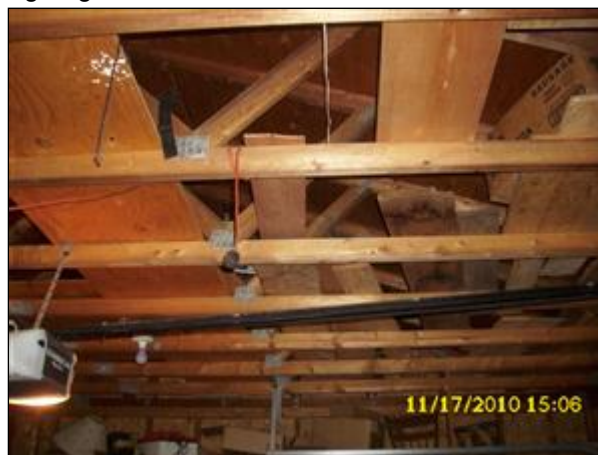
(2) Suggest not storing items in the garage trusses.

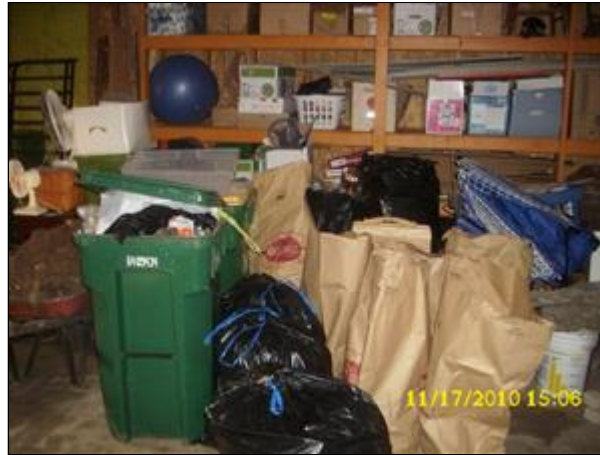
(3) Due to personal objects stored in the garage not all areas were visible. Verification of all conditions by the seller is necessary.

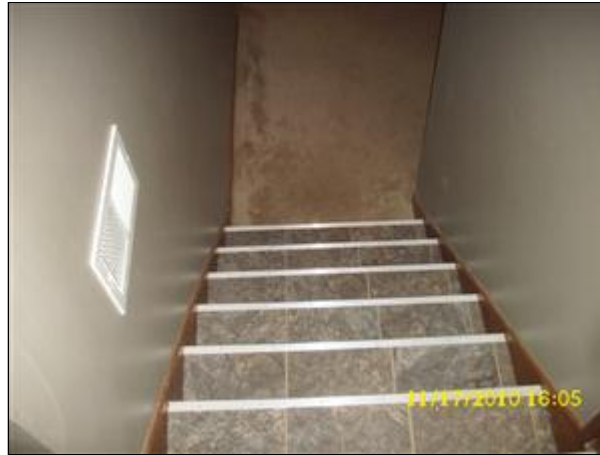
(2) A handrail is necessary on all steps with more than three steps for safety.

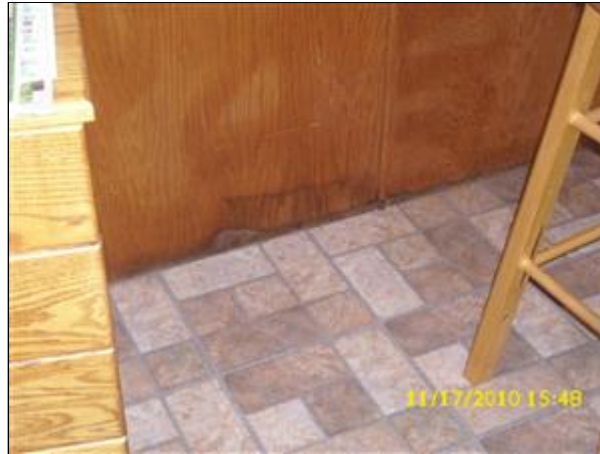
Water stains observed.

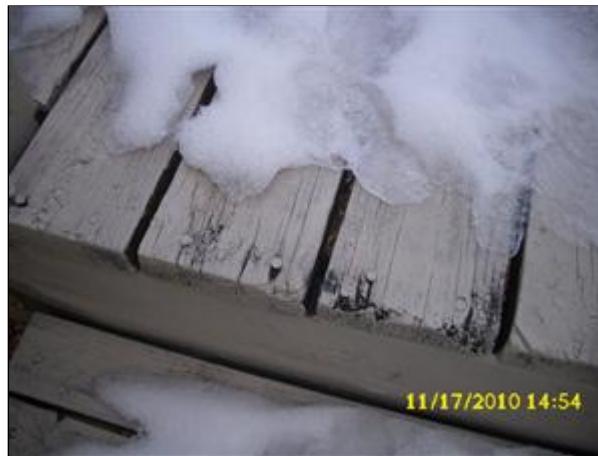
Deterioration of the flooring material observed. Future replacement will be necessary.

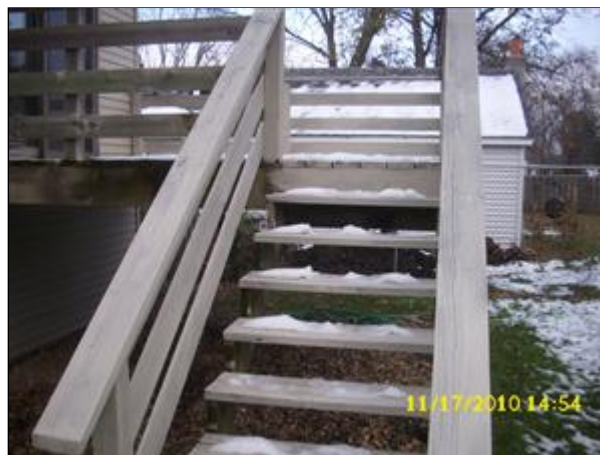
(1) Too wide of handrail observed. All handrails should be less than two inches in diameter to allow for easy grasp.

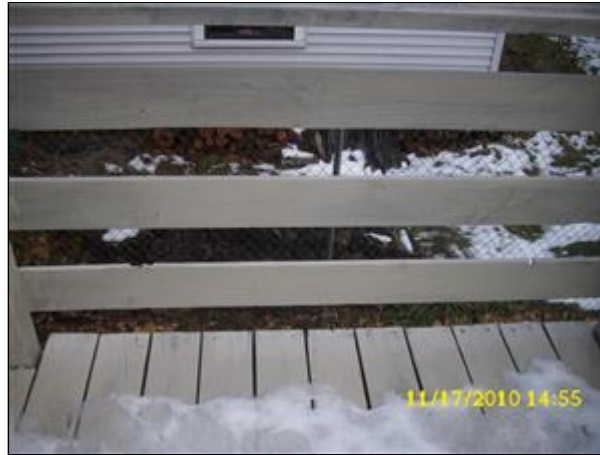
(2) The spacing of the guardrail stiles is greater than four inches. The spacing should be reduced to prevent a child safety hazard.
